## General Information

| Make | Toyota | Model | Vios |

## Body / Panel Condition

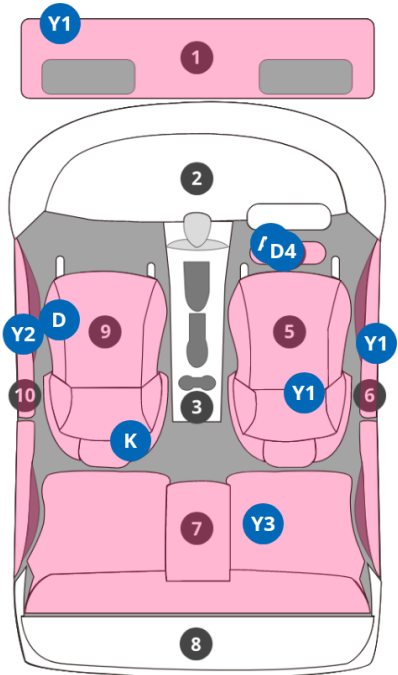
| Interior Evaluation : <span style="color: red; font-weight: bold;">C</span> | Exterior Evaluation : <span style="color: red; font-weight: bold;">C</span> |
| <b>Remarks</b><br>(L) Front Seat - Worn - Yes / Overall Interior - Animal Hair - Yes / (R) Front Trim - Grime - Minimal / (L) Front Trim - Grime - Small / Rear Seat - Grime - Medium / (L) Front Floor Mat - Cut, Crack - Medium / (L) Front Floor Mat - Worked - Large / (R) Front Seat - Grime - Minimal / Ceiling - Grime - Minimal | <b>Remarks</b><br>(R) Front Fender - Repair Traces - Yes / (R) Mirror - Scratch - Minimal / (R) Front Door, Molding - Scratch - Small / (R) Rear Door, Molding - Scratch & Dent - Large / (R) Rear Fender, Molding - Scratch & Dent - Medium / Rear Bumper, Lamps, Panels - Scratch - Small / Trunk Hood, Rear Gate - Scratch - Minimal / (L) Rear Fender, Molding - Scratch - Small / (L) Rear Door, Molding - Scratch - Small / (L) Front Door, Molding - Scratch - Small / Member (Bolted) - Dent - Yes / (L) Mirror - Scratch - Minimal / (L) Front Fender, Molding - Scratch - Minimal / Front Bumper, Grille, Lamps - Scratch - Small / Bonnet, Headlight - Scratch - Small / Roof - Scratch - Minimal |
