## General Information

<b>Make</b>	Toyota	<b>Model</b>	Innova
<b>YOM</b>	2021	<b>Odo Meter Reading</b>	237,365
<b>Registration No.</b>	NFC4661	<b>Chassis No.</b>	PA2JA8EM0M0094219
<b>CC</b>	2.8	<b>Transmission</b>	M/T
<b>Fuel Type</b>	Diesel	<b>Type of Body</b>	Wagon
<b>Colour</b>	Red Mica Metallic

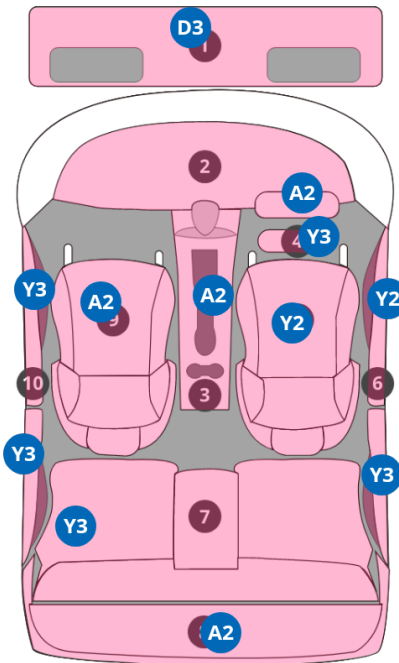
<b>Interior Evaluation :</b> <span style="float: right;"><b>D</b></span>	<b>Exterior Evaluation :</b> <span style="float: right;"><b>E</b></span>

<p><b>a</b> : Cut, Fray <b>d</b> : Loose, Deformed <b>k</b> : Animal Hair <b>s</b> : Smell <b>t</b> : Cigarette Burns <b>x</b> : Defective <b>y</b> : Stain</p>

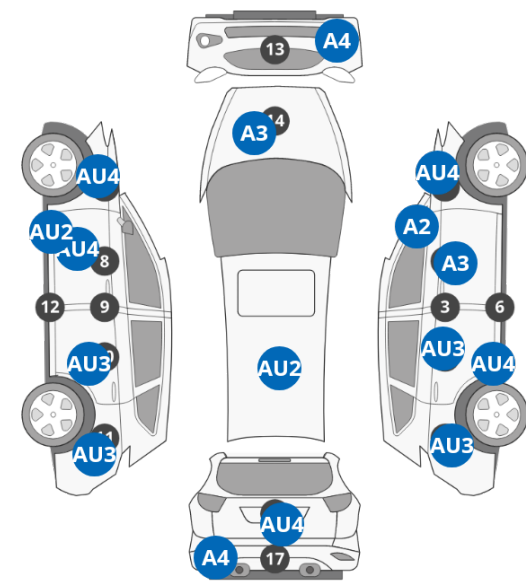
<p><b>A</b> : Scratch <b>AU</b> : Scratch &amp; Dent <b>B</b> : Modified <b>C</b> : Corrosion <b>G</b> : Stone chip <b>P</b> : Faded <b>S</b> : Rust <b>SC</b> : Rust &amp; Corrosion <b>U</b> : Dent <b>X</b> : Defective <b>Y</b> : Crack, Gap</p>
<b>Remarks</b> (R) Front Seat - Grime - Small / (R) Front Trim - Grime - Small / Rear Seat - Grime - Medium / (R) Rear Trim - Grime - Medium / Trunk Room - Worn, Scratch, Cut, Crack - Small / (L) Rear Trim - Grime - Medium / (L) Front Trim - Grime - Medium / (L) Front Seat - Cut, Crack - Small / (L) Front Floor Mat - Grime - Medium / Steering Wheel - Worn, Peel, Crack - Small / Ceiling - Crinkle - Medium / Knobs - Worn, Peel, Crack - Small	<b>Remarks</b> (R) Front Fender - Repair Traces - Yes / Bonnet - Repair Traces - Yes / (L) Front Fender - Repair Traces - Yes / (L) Rear Fender, Molding - Scratch & Dent - Medium / (L) Rear Door, Molding - Scratch & Dent - Medium / (L) Front Door, Molding - Scratch & Dent - Large / (L) Front Fender, Molding - Scratch & Dent - Large / (L) Step, In-panel, Side Spoiler - Scratch & Dent - Small / Bonnet, Headlight - Scratch - Medium / Front Bumper, Grille, Lamps - Scratch - Large / (R) Front Fender, Molding - Scratch & Dent - Large / (R) Mirror - Scratch - Small / (R) Front Door, Molding - Scratch - Medium / (R) Step, In-panel, Side Spoiler - Scratch & Dent - Large / (R) Rear Door, Molding - Scratch & Dent - Medium / (R) Rear Fender, Molding - Scratch & Dent - Medium / Roof - Scratch & Dent - Small / Rear Bumper, Lamps, Panels - Scratch - Large / Trunk Hood, Rear Gate - Scratch & Dent - Large
