## General Information

| Make | Toyota | Model | Vios |
| YOM | 2022 | Odo Meter Reading | 48,802 |

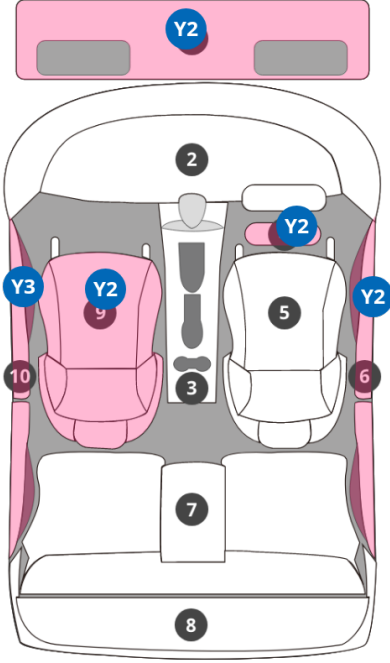
| Interior Evaluation : <b>B</b> | Exterior Evaluation : <b>D</b> |
|---|---|
| <p><b>Remarks</b></p> <p>(R) Front Trim - Grime - Small / (L) Front Trim - Grime - Medium / (L) Front Floor Mat - Grime - Small / (L) Front Seat - Grime - Small / Ceiling - Grime - Small</p> | <p><b>Remarks</b></p> <p>(R) Rear Fender - Repair Traces - Yes / (R) Front Door, Molding - Scratch - Medium / (R) Rear Fender, Molding - Repair mark - Yes / (R) Rear Door, Molding - Scratch - Small / (R) Rear Fender, Molding - Scratch - Small / Trunk Hood, Rear Gate - Scratch - Small / Rear Bumper, Lamps, Panels - Scratch &amp; Dent - Medium / (L) Rear Fender, Molding - Scratch &amp; Dent - Small / (L) Rear Door, Molding - Scratch - Small / (L) Step, In-panel, Side Spoiler - Scratch - Small / (L) Front Door, Molding - Scratch - Large / (L) Front Fender, Molding - Scratch - Minimal / Bonnet, Headlight - Scratch - Small / Front Bumper, Grille, Lamps - Scratch - Medium / (R) Front Fender, Molding - Scratch - Minimal / Roof - Dent - Minimal</p> |
