## General Information

| Make | Toyota | Model | Vios |
| Registration No. | NHM4852 | Chassis No. | PA1B18F31S4287175 |

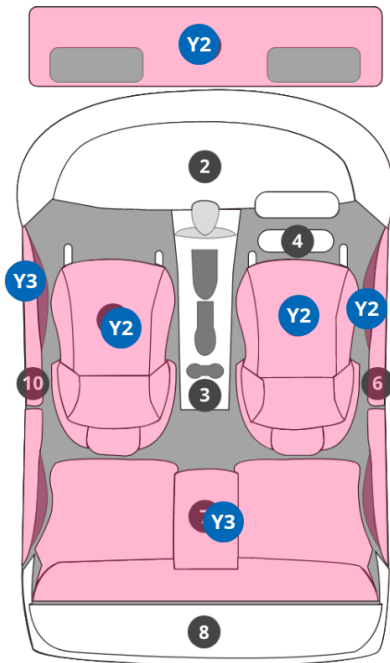
| Interior Evaluation : <b>B</b> | Exterior Evaluation : <b>E</b> |
|---|---|
| <p><b>Remarks</b><br/>(R) Front Seat - Grime - Small / (R) Front Trim - Grime - Small / Rear Seat - Grime - Medium / (L) Front Trim - Grime - Medium / (L) Front Seat - Grime - Small / Ceiling - Grime - Small</p> | <p><b>Remarks</b><br/>Roof - Scratch - Small / Trunk Hood, Rear Gate - Scratch - Large / Rear Bumper, Lamps, Panels - Scratch - Small / (L) Rear Fender, Molding - Scratch - Medium / (L) Rear Door, Molding - Scratch - Medium / (L) Front Door, Molding - Scratch - Medium / (L) Front Fender, Molding - Scratch - Small / Front Bumper, Grille, Lamps - Scratch - Medium / Bonnet, Headlight - Scratch - Medium / (R) Front Fender, Molding - Scratch - Medium / (R) Mirror - Scratch - Minimal / (R) Front Door, Molding - Scratch - Medium / (R) Rear Door, Molding - Scratch - Small / (R) Rear Fender, Molding - Scratch - Small</p> |
