## General Information

| Make | Toyota | Model | Avanza |
| Registration No. | NHQ2674 | Chassis No. | MHFAA1BY1P0022081 |

## Overall Evaluation :

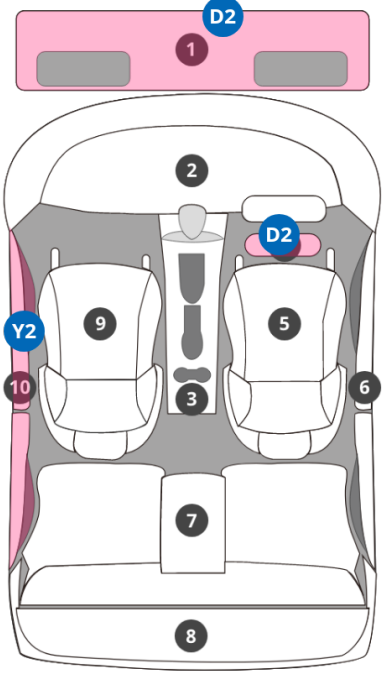
| Interior Evaluation : <b>A</b> | Exterior Evaluation : <b>E</b> |
|---|---|
| <p><b>Remarks</b><br/>(L) Front Floor Mat - Worked - Small / (L) Front Trim - Grime - Small / Ceiling - Crinkle - Small</p> | <p><b>Remarks</b><br/>(R) Front Fender, Molding - Scratch - Minimal / (R) Mirror - Scratch - Minimal / (R) Front Door, Molding - Scratch - Large / (R) Step, In-panel, Side Spoiler - Scratch &amp; Dent - Large / (R) Rear Door, Molding - Scratch - Small / (R) Rear Fender, Molding - Scratch &amp; Dent - Small / Rear Bumper, Lamps, Panels - Scratch &amp; Dent - Medium / Trunk Hood, Rear Gate - Scratch - Small / (L) Step, In-panel, Side Spoiler - Scratch &amp; Dent - Small / (L) Rear Fender, Molding - Scratch &amp; Dent - Small / (L) Rear Door, Molding - Scratch &amp; Dent - Small / (L) Front Door, Molding - Scratch - Minimal / (L) Mirror - Scratch - Small / (L) Front Fender, Molding - Scratch - Minimal / Front Bumper, Grille, Lamps - Scratch &amp; Dent - Medium / Bonnet, Headlight - Scratch - Small / Roof - Scratch - Minimal</p> |
