General Information

Make	Toyota	Model	Rush
YOM	2023	Odo Meter Reading	20,097
Registration No.	NIN6326	Chassis No.	MHKE8FF2PPK009922
CC	1.5	Transmission	A/T
Fuel Type	Gas	Type of Body	SUV
Colour	Silver

Body / Panel Condition

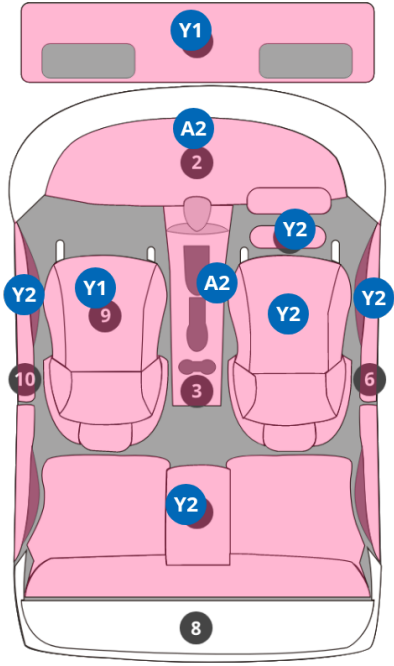
Interior Evaluation : B	Exterior Evaluation : C

<p>a : Cut, Fray d : Loose, Deformed k : Animal Hair s : Smell t : Cigarette Burns x : Defective y : Stain</p>

<p>A : Scratch AU : Scratch & Dent B : Modified C : Corrosion G : Stone chip P : Faded S : Rust SC : Rust & Corrosion U : Dent X : Defective Y : Crack, Gap</p>
<p>Remarks (R) Front Seat - Grime - Small / (R) Front Trim - Grime - Small / Rear Seat - Grime - Small / (L) Front Trim - Grime - Small / (L) Front Seat - Grime - Minimal / (L) Front Floor Mat - Grime - Small / Ceiling - Grime - Minimal / Dashboard - Worn, Scratch, Cut, Crack - Small / Console, Switchs, Vents - Worn, Scratch, Cut, Crack - Small</p>	<p>Remarks (L) Rear Door, Molding - Scratch - Small / (L) Step, In-panel, Side Spoiler - Scratch - Small / (L) Front Door, Molding - Scratch & Dent - Minimal / (L) Front Fender, Molding - Scratch - Small / (L) Mirror - Scratch - Minimal / Front Bumper, Grille, Lamps - Scratch - Medium / (R) Mirror - Scratch - Minimal / (R) Front Door, Molding - Scratch - Minimal / (R) Rear Door, Molding - Scratch - Small / (R) Rear Fender, Molding - Scratch - Small / Rear Bumper, Lamps, Panels - Scratch - Small / Trunk Hood, Rear Gate - Scratch - Small / (L) Rear Fender, Molding - Scratch - Minimal / (R) Front Fender, Molding - Scratch - Minimal / Roof - Scratch - Minimal / Bonnet, Headlight - Scratch - Minimal</p>
