## General Information

| Make | Toyota | Model | Hiace |
| Registration No. | CBL5154 | Chassis No. | JTFNAFAP5L8017231 |

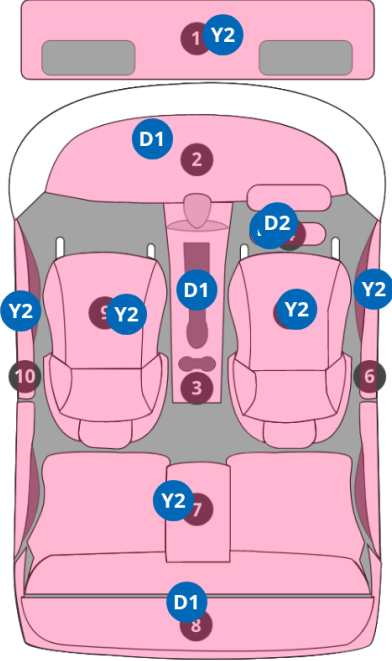
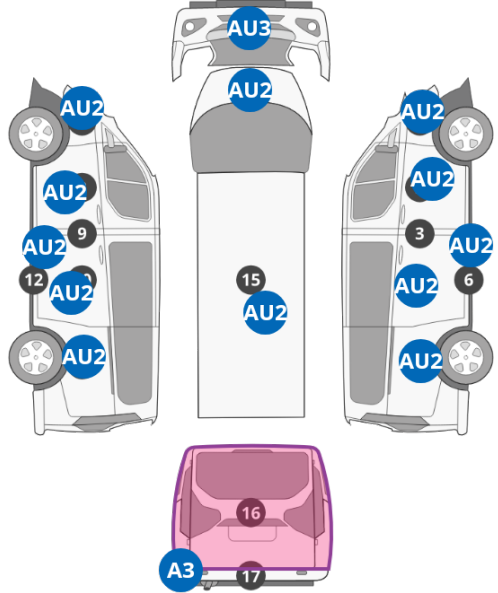
| Interior Evaluation : <b>B</b> | Exterior Evaluation : <b>D</b> |
|---|---|
| <p><b>a</b> : Cut, Fray <b>d</b> : Loose, Deformed <b>k</b> : Animal Hair <b>s</b> : Smell <b>t</b> : Cigarette Burns <b>x</b> : Defective <b>y</b> : Stain</p> | <p><b>A</b> : Scratch <b>AU</b> : Scratch &amp; Dent <b>B</b> : Modified <b>C</b> : Corrosion <b>G</b> : Stone chip <b>P</b> : Faded <b>S</b> : Rust <b>SC</b> : Rust &amp; Corrosion <b>U</b> : Dent <b>X</b> : Defective <b>Y</b> : Crack, Gap</p> |
| <p><b>Remarks</b></p> <p>Ceiling - Grime - Small / (L) Front Trim - Grime - Small / (R) Front Trim - Grime - Small / Rear Seat - Grime - Small / (L) Front Seat - Grime - Small / (R) Front Seat - Grime - Small / Console, Switchs, Vents - Worked - Minimal / Dashboard - Worked - Minimal / (R) Front Floor Mat - Worked - Small / (L) Front Floor Mat - Worked - Small / Trunk Room - Worked - Minimal</p> | <p><b>Remarks</b></p> <p>Trunk Hood, Rear Gate - Repair Traces - Yes / (L) Front Fender, Molding - Scratch &amp; Dent - Small / (R) Front Fender, Molding - Scratch &amp; Dent - Small / Bonnet, Headlight - Scratch &amp; Dent - Small / Roof - Scratch &amp; Dent - Small / (R) Front Door, Molding - Scratch &amp; Dent - Small / (R) Step, In-panel, Side Spoiler - Scratch &amp; Dent - Small / (R) Rear Door, Molding - Scratch &amp; Dent - Small / (R) Rear Fender, Molding - Scratch &amp; Dent - Small / Trunk Hood, Rear Gate - Repair mark - Yes / (L) Rear Fender, Molding - Scratch &amp; Dent - Small / Rear Bumper, Lamps, Panels - Scratch - Medium / (L) Rear Door, Molding - Scratch &amp; Dent - Small / (L) Front Door, Molding - Scratch &amp; Dent - Small / Front Bumper, Grille, Lamps - Scratch &amp; Dent - Medium / (L) Step, In-panel, Side Spoiler - Scratch &amp; Dent - Small</p> |
