## General Information

| Make | Toyota | Model | Vios |
| Registration No. | CCQ1045 | Chassis No. | PA1B18F36S4287866 |

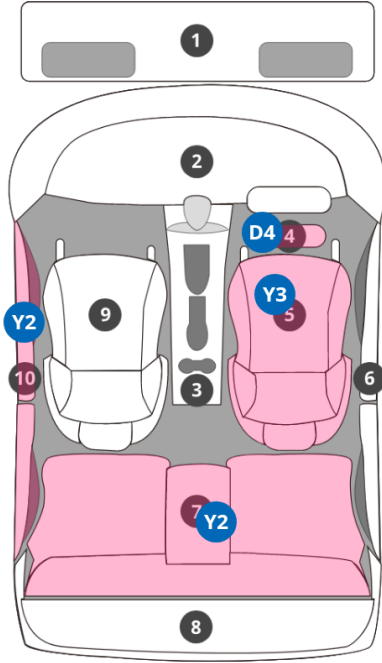
| Interior Evaluation : <span style="color: red;">C</span> | Exterior Evaluation : <span style="color: red;">C</span> |
|---|---|
| <b>Remarks</b><br>(R) Front Seat - Grime - Medium / Rear Seat - Grime - Small / (L) Front Floor Mat - Worked - Large / (L) Front Trim - Grime - Small | <b>Remarks</b><br>(L) Rear Door, Molding - Dent - Small / Bonnet, Headlight - Scratch - Small / (L) Front Fender, Molding - Scratch - Small / (L) Front Door, Molding - Scratch - Medium / Rear Bumper, Lamps, Panels - Scratch - Large / Trunk Hood, Rear Gate - Scratch - Medium / (R) Rear Fender, Molding - Scratch - Minimal / (R) Rear Door, Molding - Scratch - Small / (R) Front Door, Molding - Scratch - Small / (R) Front Fender, Molding - Scratch - Minimal / Front Bumper, Grille, Lamps - Scratch - Small / (L) Rear Fender, Molding - Scratch - Minimal |
