General Information

Make	Toyota	Model	Vios
YOM	2025	Odo Meter Reading	16,122
Registration No.	DBQ4079	Chassis No.	PA1B18F3XR4269137
CC	1.3	Transmission	CVT
Fuel Type	Gas	Type of Body	Sedan
Colour	Blue

Body / Panel Condition

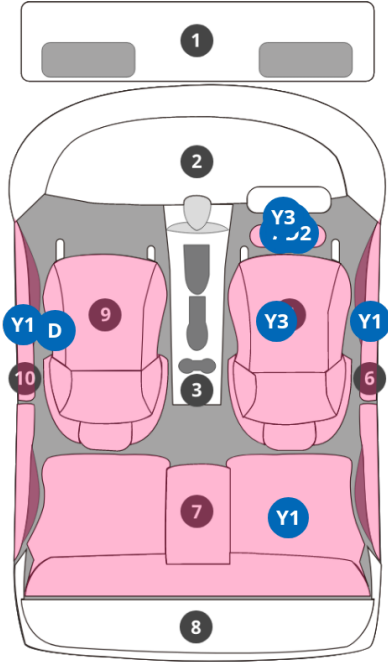
Interior Evaluation : C	Exterior Evaluation : E

<p>a : Cut, Fray d : Loose, Deformed k : Animal Hair s : Smell t : Cigarette Burns x : Defective y : Stain</p>

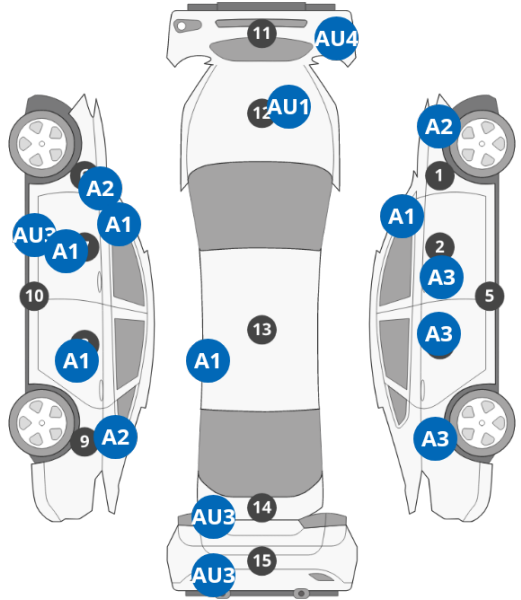
<p>A : Scratch AU : Scratch & Dent B : Modified C : Corrosion G : Stone chip P : Faded S : Rust SC : Rust & Corrosion U : Dent X : Defective Y : Crack, Gap</p>
<p>Remarks Mat Other - Grime - Medium / (R) Front Seat - Grime - Medium / (L) Front Seat - Worn - Yes / (L) Front Floor Mat - Cut, Crack - Small / Carpet - Worn, Scratch, Cut, Crack - Small / (L) Front Floor Mat - Worked - Small / (R) Front Trim - Grime - Minimal / (L) Front Trim - Grime - Minimal / Rear Seat - Grime - Minimal / (R) Front Floor Mat - Grime - Medium</p>	<p>Remarks (R) Mirror - Scratch - Minimal / (R) Front Fender, Molding - Scratch - Small / (R) Front Door, Molding - Scratch - Medium / (R) Rear Door, Molding - Scratch - Medium / (R) Rear Fender, Molding - Scratch - Medium / Rear Bumper, Lamps, Panels - Scratch & Dent - Medium / Trunk Hood, Rear Gate - Scratch & Dent - Medium / (L) Rear Fender, Molding - Scratch - Small / (L) Step, In-panel, Side Spoiler - Scratch & Dent - Medium / (L) Front Door, Molding - Scratch - Minimal / (L) Rear Door, Molding - Scratch - Minimal / (L) Front Fender, Molding - Scratch - Small / (L) Mirror - Scratch - Minimal / Front Bumper, Grille, Lamps - Scratch & Dent - Large / Bonnet, Headlight - Scratch & Dent - Minimal / Roof - Scratch - Minimal</p>

<p>Inspector Notes</p>
<p>with warranty booklet and jack, no tools, with spare tire, with LTO plate, scratched and cracked tail light</p>
