## General Information

| Make | Toyota | Model | Vios |
| YOM | 2026 | Odo Meter Reading | 5,337 |
| Registration No. | NJQ9690 | Chassis No. | PA1B18F30S4296823 |

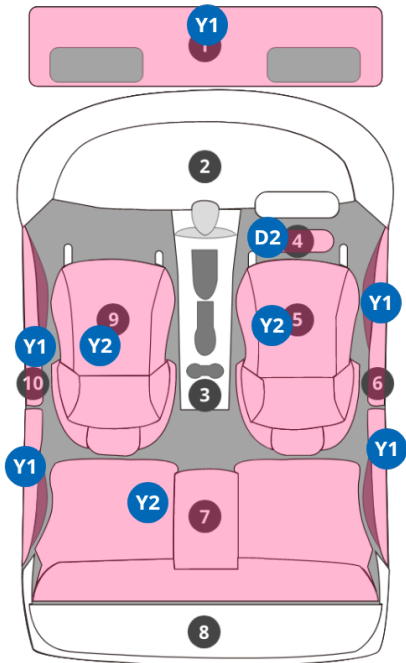
| Interior Evaluation : <b>B</b> | Exterior Evaluation : <b>C</b> |
| <b>Remarks</b><br>(L) Front Seat - Grime - Small / (R) Front Seat - Grime - Small / Rear Seat - Grime - Small / Ceiling - Grime - Minimal / (L) Front Trim - Grime - Minimal / (R) Front Trim - Grime - Minimal / (L) Rear Trim - Grime - Minimal / (R) Rear Trim - Grime - Minimal / (L) Front Floor Mat - Worked - Small | <b>Remarks</b><br>Roof - Repair Traces - Yes / (L) Front Door, Molding - Dent - Small / (L) Rear Door, Molding - Scratch & Dent - Small / (L) Step, In-panel, Side Spoiler - Scratch & Dent - Small / (R) Step, In-panel, Side Spoiler - Scratch & Dent - Small / (R) Front Door, Molding - Scratch & Dent - Small / (R) Rear Door, Molding - Scratch & Dent - Small / Roof - Scratch - Small / Bonnet, Headlight - Scratch & Dent - Small / (R) Front Fender, Molding - Scratch - Small / Trunk Hood, Rear Gate - Scratch - Small / (R) Rear Fender, Molding - Scratch & Dent - Small / (L) Rear Fender, Molding - Scratch & Dent - Small / Rear Bumper, Lamps, Panels - Scratch - Small / (L) Front Fender, Molding - Scratch - Small / Front Bumper, Grille, Lamps - Scratch & Dent - Minimal |

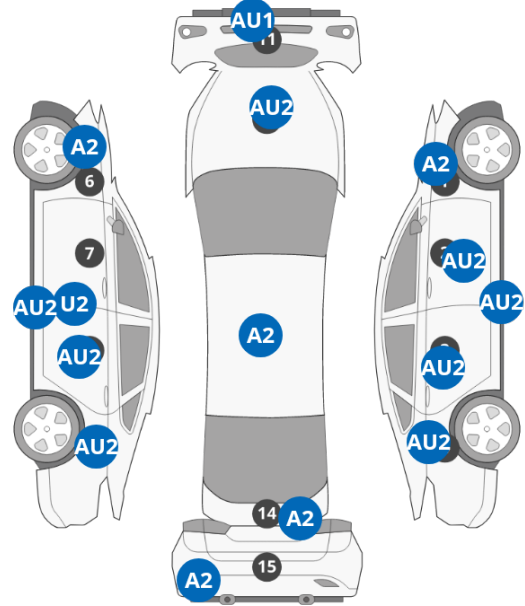
| Inspector Notes |
|---|
| With reverse camera, with inc tools & jack, with spare tire, no spare key, no manual & warranty booklet, no LTO plate, scratches on taillight. |
