## General Information

| Make | Toyota | Model | Vios |
| YOM | 2024 | Odo Meter Reading | 41,649 |
| Registration No. | NFR8567 | Chassis No. | PA1B18F39R4258789 |

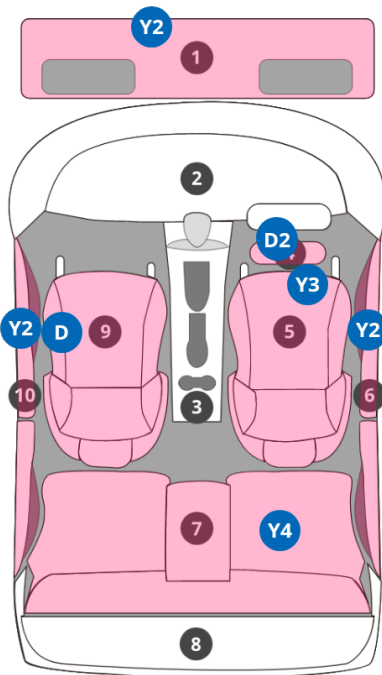
| Interior Evaluation : <span style="color: red;">C</span> | Exterior Evaluation : <span style="color: red;">D</span> |
|---|---|
| <b>Remarks</b><br>Rear Seat - Grime - Large / (L) Front Seat - Worn - Yes / (R) Front Seat - Grime - Medium / Ceiling - Grime - Small / (R) Front Trim - Grime - Small / (L) Front Trim - Grime - Small / (L) Front Floor Mat - Cut, Crack - Small / (L) Front Floor Mat - Worked - Small | <b>Remarks</b><br>Member (Bolted) - Dent - Yes / (R) Mirror - Scratch - Minimal / (R) Front Fender, Molding - Scratch - Minimal / (R) Front Door, Molding - Scratch & Dent - Small / (R) Rear Door, Molding - Scratch - Medium / (R) Rear Fender, Molding - Scratch - Medium / Rear Bumper, Lamps, Panels - Scratch - Minimal / (L) Rear Fender, Molding - Scratch - Small / (L) Rear Door, Molding - Scratch - Small / (L) Front Door, Molding - Scratch - Minimal / (L) Mirror - Scratch - Small / (L) Front Fender, Molding - Scratch & Dent - Small / Front Bumper, Grille, Lamps - Scratch - Medium / Bonnet, Headlight - Scratch - Small / Roof - Scratch - Small / Trunk Hood, Rear Gate - Crack, Gap - Medium |

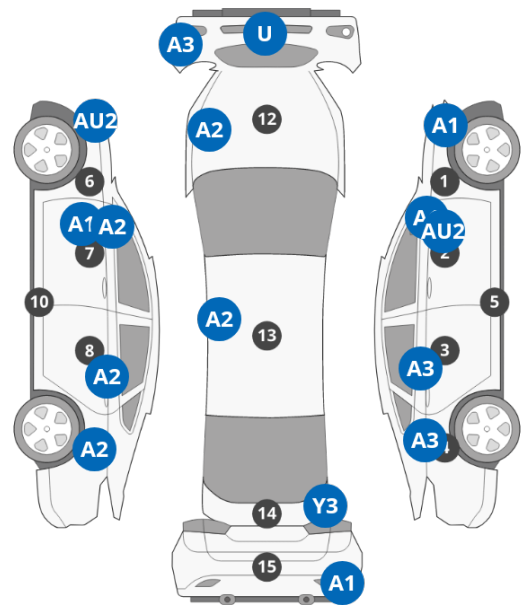
| Inspector Notes |
|---|
| with warranty booklet, with jack, incomplete tools, no spare tire, with LTO plate, scratches on tail light |
