## General Information

| Make | Toyota | Model | Vios |
| Registration No. | NHR8239 | Chassis No. | PA1B18F39P4234554 |

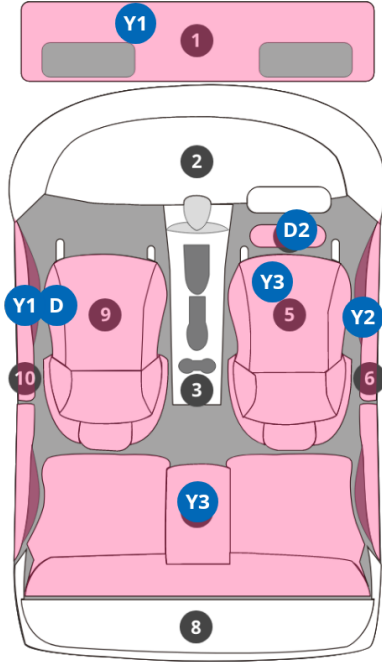
| Interior Evaluation : <span style="color: red; font-weight: bold;">B</span> | Exterior Evaluation : <span style="color: red; font-weight: bold;">C</span> |
| <b>Remarks</b><br>Rear Seat - Grime - Medium / (R) Front Seat - Grime - Medium / (L) Front Seat - Worn - Yes / (R) Front Trim - Grime - Small / (L) Front Trim - Grime - Minimal / (L) Front Floor Mat - Worked - Small / Ceiling - Grime - Minimal | <b>Remarks</b><br>(R) Front Door - Repair Traces - Yes / (R) Front Fender - Repair Traces - Yes / (L) Front Fender - Repair Traces - Yes / (R) Front Fender, Molding - Scratch - Minimal / (R) Front Door, Molding - Dent - Minimal / (R) Rear Door, Molding - Scratch - Small / (R) Rear Fender, Molding - Dent - Small / Rear Bumper, Lamps, Panels - Scratch - Small / Trunk Hood, Rear Gate - Scratch & Dent - Small / (L) Rear Fender, Molding - Scratch & Dent - Small / (L) Rear Door, Molding - Scratch - Minimal / (L) Front Door, Molding - Scratch - Minimal / (L) Mirror - Scratch - Minimal / (L) Front Fender, Molding - Scratch - Minimal / Member (Bolted) - Dent - Yes / Front Bumper, Grille, Lamps - Scratch - Small / Bonnet, Headlight - Scratch - Minimal / Roof - Scratch - Small |
