General Information

Make	Toyota	Model	Wigo
YOM	2025	Odo Meter Reading	17,551
Registration No.	NJF1226	Chassis No.	MHKAA1BCORJ028408
CC	1.0	Transmission	CVT
Fuel Type	Gas	Type of Body	Hatchback
Colour	Gray

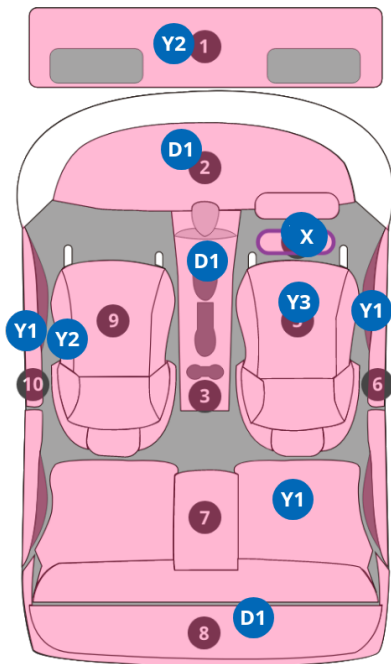
Interior Evaluation : B	Exterior Evaluation : E

<p>a : Cut, Fray d : Loose, Deformed k : Animal Hair s : Smell t : Cigarette Burns x : Defective y : Stain</p>

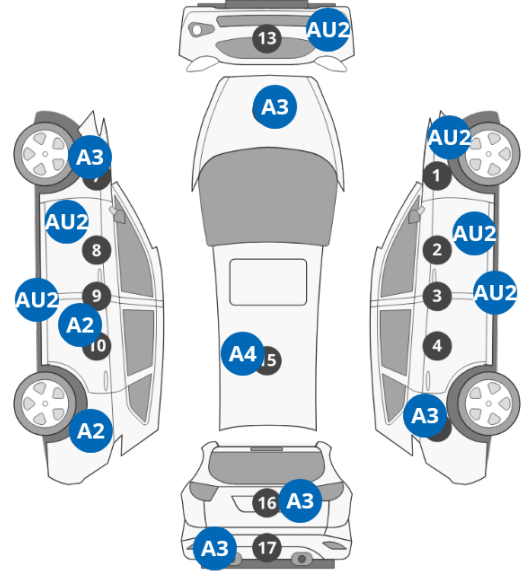
<p>A : Scratch AU : Scratch & Dent B : Modified C : Corrosion G : Stone chip P : Faded S : Rust SC : Rust & Corrosion U : Dent X : Defective Y : Crack, Gap</p>
<p>Remarks (L) Front Floor Mat - Grime - Medium / Ceiling - Grime - Small / Dashboard - Worked - Minimal / (R) Front Seat - Grime - Medium / (L) Front Seat - Grime - Small / Console, Switchs, Vents - Worked - Minimal / Mat Other - Missing - Yes / (L) Front Trim - Grime - Minimal / (R) Front Trim - Grime - Minimal / Rear Seat - Grime - Minimal / Trunk Room - Worked - Minimal</p>	<p>Remarks Trunk Hood, Rear Gate - Scratch - Medium / (R) Rear Fender, Molding - Scratch - Medium / Rear Bumper, Lamps, Panels - Scratch - Medium / Roof - Scratch - Large / (L) Rear Fender, Molding - Scratch - Small / (L) Rear Door, Molding - Scratch - Small / (L) Step, In-panel, Side Spoiler - Scratch & Dent - Small / (R) Step, In-panel, Side Spoiler - Scratch & Dent - Small / (L) Front Door, Molding - Scratch & Dent - Small / (L) Front Fender, Molding - Scratch - Medium / Front Bumper, Grille, Lamps - Scratch & Dent - Small / Bonnet, Headlight - Scratch - Medium / (R) Front Door, Molding - Scratch & Dent - Small / (R) Front Fender, Molding - Scratch & Dent - Small</p>
