## General Information

| Make | Toyota | Model | Vios |
| YOM | 2025 | Odo Meter Reading | 13,621 |
| Registration No. | NJF2686 | Chassis No. | PA1B18F36R4274321 |

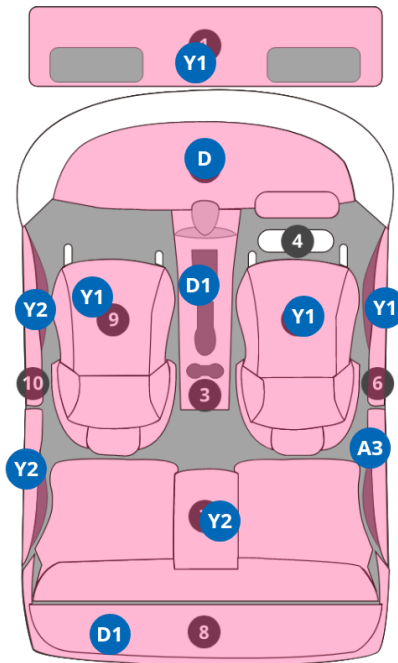
| <b>Interior Evaluation :</b> <b>B</b> | <b>Exterior Evaluation :</b> <b>D</b> |
| <b>Remarks</b><br>Ceiling - Grime - Minimal / Dashboard - Traces of Adhesive Tape - Yes / (R) Rear Trim - Cut, Crack - Medium / (L) Rear Trim - Grime - Small / (L) Front Trim - Grime - Small / (R) Front Trim - Grime - Minimal / (L) Front Seat - Grime - Minimal / (R) Front Seat - Grime - Minimal / Rear Seat - Grime - Small / Console, Switches, Vents - Worked - Minimal / Trunk Room - Worked - Minimal | <b>Remarks</b><br>Trunk Hood, Rear Gate - Scratch & Dent - Minimal / Rear Bumper, Lamps, Panels - Scratch & Dent - Medium / (R) Rear Fender, Molding - Scratch & Dent - Small / (R) Rear Door, Molding - Scratch & Dent - Minimal / (R) Front Door, Molding - Scratch & Dent - Small / (R) Step, In-panel, Side Spoiler - Scratch & Dent - Small / (R) Front Fender, Molding - Scratch - Minimal / Front Bumper, Grille, Lamps - Crack, Gap - Medium / Bonnet, Headlight - Scratch & Dent - Medium / Roof - Scratch & Dent - Small / (L) Front Fender, Molding - Scratch & Dent - Medium / (L) Front Door, Molding - Scratch & Dent - Small / (L) Rear Door, Molding - Scratch & Dent - Small / (L) Rear Fender, Molding - Scratch - Small / (L) Step, In-panel, Side Spoiler - Scratch & Dent - Small |

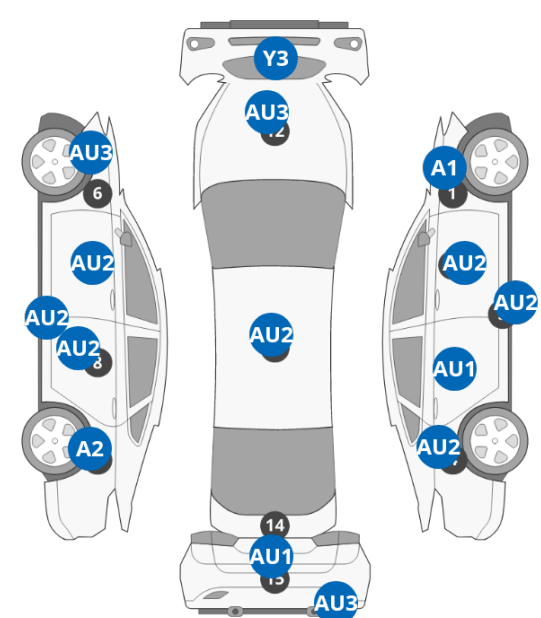
| with LTO plate, with manual & warranty booklet, with reverse camera, with spare tire, with incomplete tools & jack, with spare key, scratches on taillight. |
