## General Information

| Make | Toyota | Model | Vios |
| YOM | 2026 | Odo Meter Reading | 7,231 |
| Registration No. | NKU1045 | Chassis No. | PA1B18F34S4294881 |

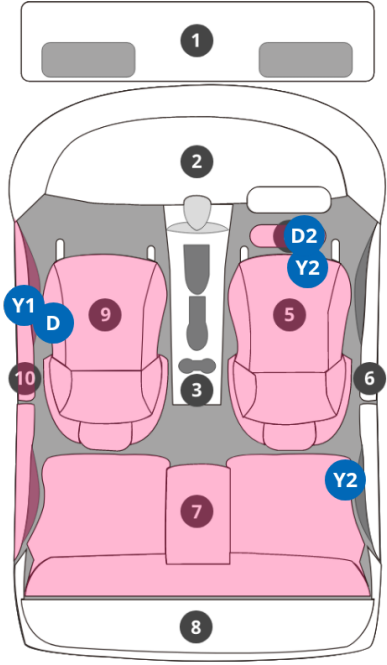
| Interior Evaluation : <b>B</b> | Exterior Evaluation : <b>C</b> |
|---|---|
| <b>Remarks</b><br>(R) Front Seat - Grime - Small / (L) Front Seat - Worn - Yes / (L) Front Trim - Grime - Minimal / (L) Front Floor Mat - Worked - Small / Rear Seat - Grime - Small | <b>Remarks</b><br>(R) Front Fender, Molding - Dent - Medium / (R) Mirror - Scratch - Minimal / (R) Rear Door, Molding - Scratch - Small / (R) Front Door, Molding - Scratch - Small / (R) Rear Fender, Molding - Scratch - Minimal / Rear Bumper, Lamps, Panels - Dent - Minimal / Trunk Hood, Rear Gate - Scratch - Small / (L) Rear Fender, Molding - Scratch - Minimal / (L) Front Door, Molding - Scratch - Minimal / (L) Rear Door, Molding - Scratch - Minimal / (L) Mirror - Scratch - Small / (L) Front Fender, Molding - Scratch - Minimal / Front Bumper, Grille, Lamps - Scratch - Small / Bonnet, Headlight - Scratch - Minimal / Roof - Scratch - Small |

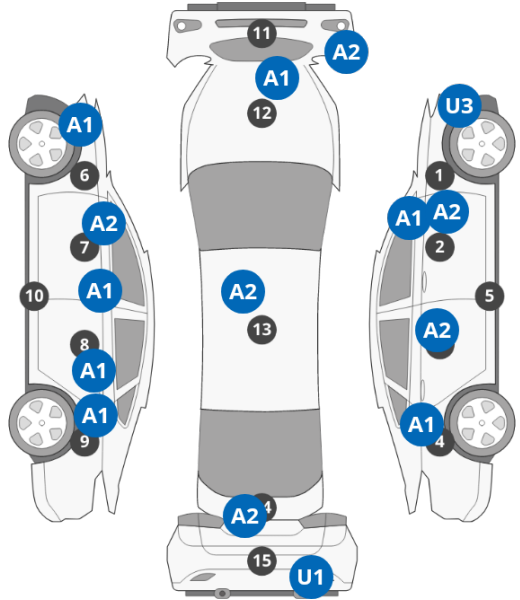
with warranty booklet, jack and tools, with spare tire and LTO PLATE, scratches on tail light
