General Information

Make	Toyota	Model	Vios
YOM	2025	Odo Meter Reading	7,980
Registration No.	DBU8135	Chassis No.	PA1B18F3XS4289104
CC	1.3	Transmission	CVT
Fuel Type	Gas	Type of Body	Sedan
Colour	Red

Body / Panel Condition

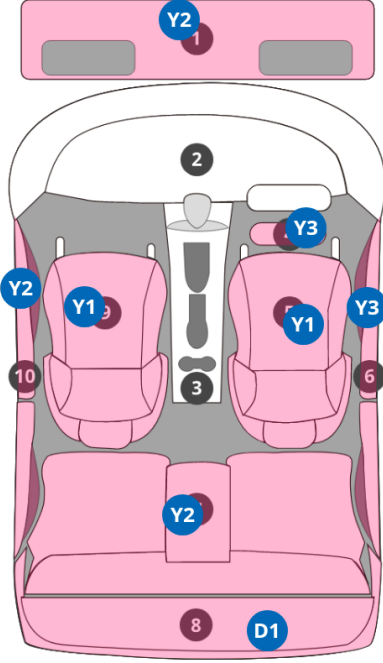
Interior Evaluation : B	Exterior Evaluation : E

<p>a : Cut, Fray d : Loose, Deformed k : Animal Hair s : Smell t : Cigarette Burns x : Defective y : Stain</p>

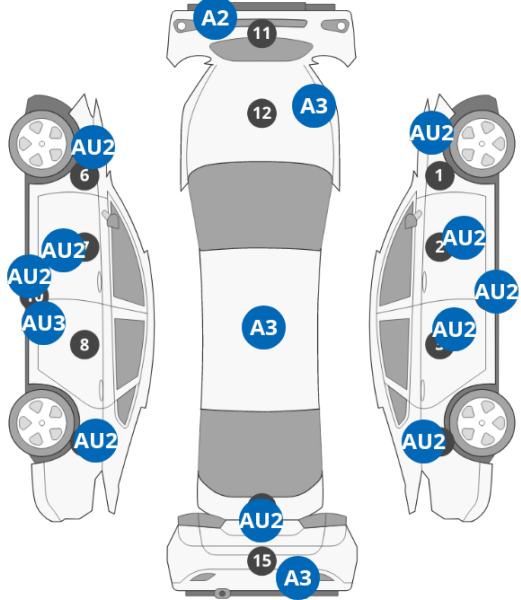
<p>A : Scratch AU : Scratch & Dent B : Modified C : Corrosion G : Stone chip P : Faded S : Rust SC : Rust & Corrosion U : Dent X : Defective Y : Crack, Gap</p>
<p>Remarks (L) Front Floor Mat - Grime - Medium / (R) Front Trim - Grime - Medium / (L) Front Trim - Grime - Small / Rear Seat - Grime - Small / Ceiling - Grime - Small / (L) Front Seat - Grime - Minimal / (R) Front Seat - Grime - Minimal / Trunk Room - Worked - Minimal</p>	<p>Remarks Bonnet - Repair Traces - Yes / (L) Front Fender - Repair Traces - Yes / (L) Front Fender, Molding - Scratch & Dent - Small / Bonnet, Headlight - Scratch - Medium / (R) Front Fender, Molding - Scratch & Dent - Small / (R) Front Door, Molding - Scratch & Dent - Small / (R) Step, In-panel, Side Spoiler - Scratch & Dent - Small / (R) Rear Door, Molding - Scratch & Dent - Small / (R) Rear Fender, Molding - Scratch & Dent - Small / Rear Bumper, Lamps, Panels - Scratch - Medium / Trunk Hood, Rear Gate - Scratch & Dent - Small / (L) Rear Fender, Molding - Scratch & Dent - Small / Roof - Scratch - Medium / (L) Rear Door, Molding - Scratch & Dent - Medium / (L) Front Door, Molding - Scratch & Dent - Small / (L) Step, In-panel, Side Spoiler - Scratch & Dent - Small / Front Bumper, Grille, Lamps - Scratch - Small</p>
