General Information

Make	Toyota	Model	Vios
YOM	2024	Odo Meter Reading	10,800
Registration No.	NFR9666	Chassis No.	PA1B18F35R4258062
CC	1.3	Transmission	CVT
Fuel Type	Gas	Type of Body	Sedan
Colour	Blue

Body / Panel Condition

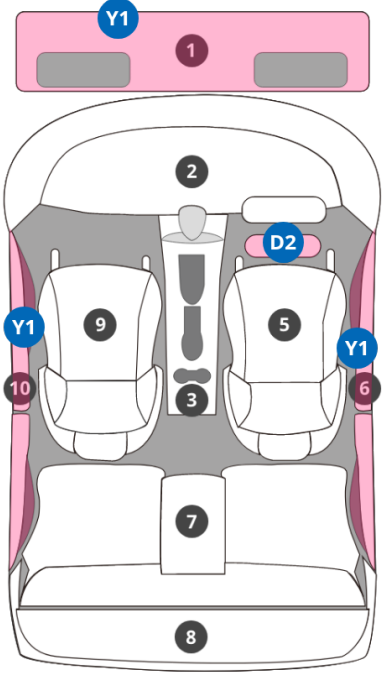
Interior Evaluation : A	Exterior Evaluation : B

<p>a : Cut, Fray d : Loose, Deformed k : Animal Hair s : Smell t : Cigarette Burns x : Defective y : Stain</p>

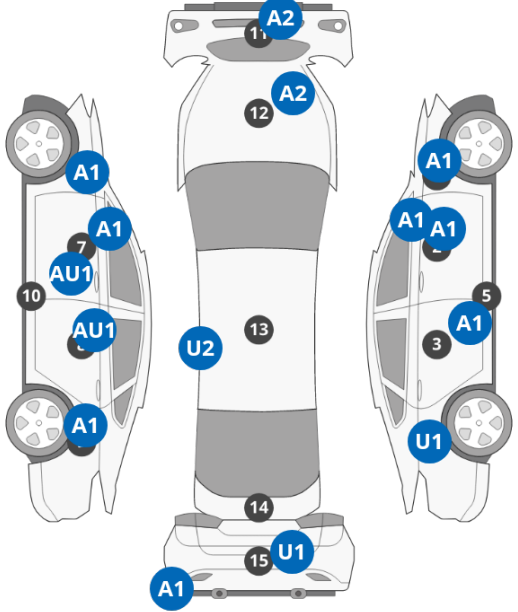
<p>A : Scratch AU : Scratch & Dent B : Modified C : Corrosion G : Stone chip P : Faded S : Rust SC : Rust & Corrosion U : Dent X : Defective Y : Crack, Gap</p>
<p>Remarks (L) Front Floor Mat - Worked - Small / (R) Front Trim - Grime - Minimal / (L) Front Trim - Grime - Minimal / Ceiling - Grime - Minimal</p>	<p>Remarks (R) Front Fender, Molding - Scratch - Minimal / (R) Mirror - Scratch - Minimal / (R) Front Door, Molding - Scratch - Minimal / (R) Rear Door, Molding - Scratch - Minimal / (R) Rear Fender, Molding - Dent - Minimal / Rear Bumper, Lamps, Panels - Scratch - Minimal / Trunk Hood, Rear Gate - Dent - Minimal / (L) Rear Fender, Molding - Scratch - Minimal / (L) Rear Door, Molding - Scratch & Dent - Minimal / (L) Front Door, Molding - Scratch & Dent - Minimal / (L) Mirror - Scratch - Minimal / (L) Front Fender, Molding - Scratch - Minimal / Front Bumper, Grille, Lamps - Scratch - Small / Bonnet, Headlight - Scratch - Small / Roof - Dent - Small</p>

<p>Inspector Notes</p>
<p>no warranty booklet, with jack, incomplete tools, with spare tire, with LTO plate, scratches on tail light</p>
