General Information

Make	Toyota	Model	Vios
YOM	2025	Odo Meter Reading	16,941
Registration No.	HAH5890	Chassis No.	PA1B18F32R4279645
CC	1.3	Transmission	CVT
Fuel Type	Gas	Type of Body	Sedan
Colour	Blackish Red Mica

Body / Panel Condition

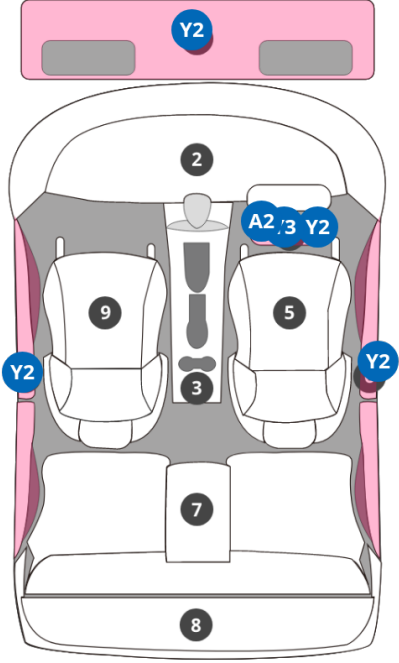
Interior Evaluation : B	Exterior Evaluation : D

<p>a : Cut, Fray d : Loose, Deformed k : Animal Hair s : Smell t : Cigarette Burns x : Defective y : Stain</p>

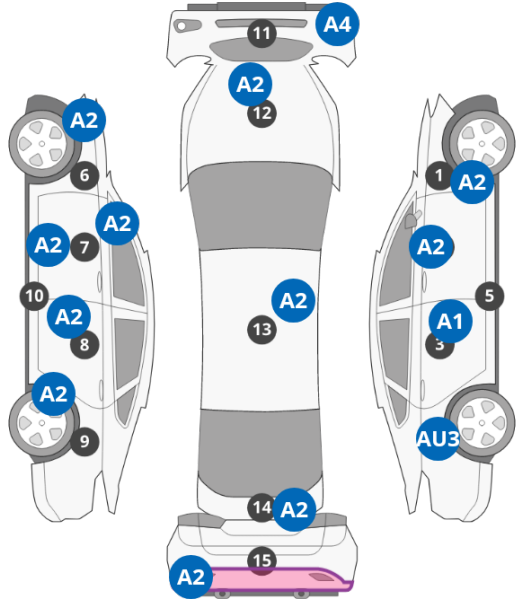
<p>A : Scratch AU : Scratch & Dent B : Modified C : Corrosion G : Stone chip P : Faded S : Rust SC : Rust & Corrosion U : Dent X : Defective Y : Crack, Gap</p>
Remarks (R) Front Floor Mat - Grime - Small / Ceiling - Grime - Small / (R) Front Trim - Grime - Small / Mat Other - Grime - Medium / (L) Front Floor Mat - Cut, Crack - Small / (L) Front Trim - Grime - Small	Remarks (R) Front Fender - Repair Traces - Yes / (L) Front Fender - Repair Traces - Yes / Rear Bumper, Lamps, Panels - Repair mark - Difference in Color / (R) Rear Fender, Molding - Scratch & Dent - Medium / (R) Front Door, Molding - Scratch - Small / (R) Rear Door, Molding - Scratch - Minimal / (R) Front Fender, Molding - Scratch - Small / Bonnet, Headlight - Scratch - Small / Front Bumper, Grille, Lamps - Scratch - Large / (L) Front Fender, Molding - Scratch - Small / (L) Mirror - Scratch - Small / (L) Rear Door, Molding - Scratch - Small / (L) Front Door, Molding - Scratch - Small / (L) Rear Fender, Molding - Scratch - Small / Trunk Hood, Rear Gate - Scratch - Small / Rear Bumper, Lamps, Panels - Scratch - Small / Roof - Scratch - Small
