General Information

Make	Toyota	Model	Hilux Tamaraw
YOM	2025	Odo Meter Reading	8,031
Registration No.	NJC7635	Chassis No.	PAHACACA4S6425412
CC	2.4	Transmission	M/T
Fuel Type	Diesel	Type of Body	Utility Passenger
Colour	White

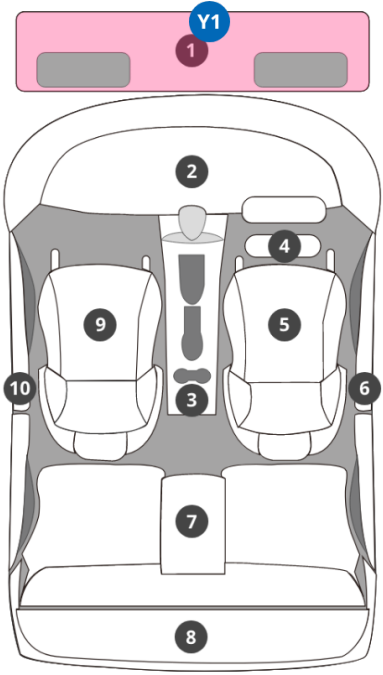
Interior Evaluation : A	Exterior Evaluation : C

<p>a : Cut, Fray d : Loose, Deformed k : Animal Hair s : Smell t : Cigarette Burns x : Defective y : Stain</p>

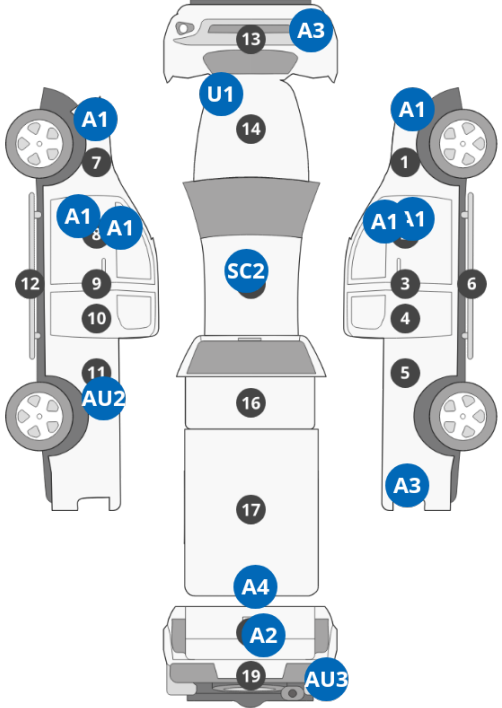
<p>A : Scratch AU : Scratch & Dent B : Modified C : Corrosion G : Stone chip P : Faded S : Rust SC : Rust & Corrosion U : Dent X : Defective Y : Crack, Gap</p>
Remarks Ceiling - Grime - Minimal	Remarks (R) Front Fender, Molding - Scratch - Minimal / (R) Front Door, Molding - Scratch - Minimal / (R) Mirror - Scratch - Minimal / (R) Side Gate - Scratch - Medium / Rear Bumper, Lamps, Panels - Scratch & Dent - Medium / Rear Gate - Scratch - Small / Cargo Bed Floor - Scratch - Large / (L) Side Gate - Scratch & Dent - Small / (L) Mirror - Scratch - Minimal / (L) Front Door, Molding - Scratch - Minimal / (L) Front Fender, Molding - Scratch - Minimal / Front Bumper, Grille, Lamps - Scratch - Medium / Bonnet, Headlight - Dent - Minimal / Roof - Rust, Corrosion - Small
