## General Information

| Make | Toyota | Model | Hiace |

## Body / Panel Condition

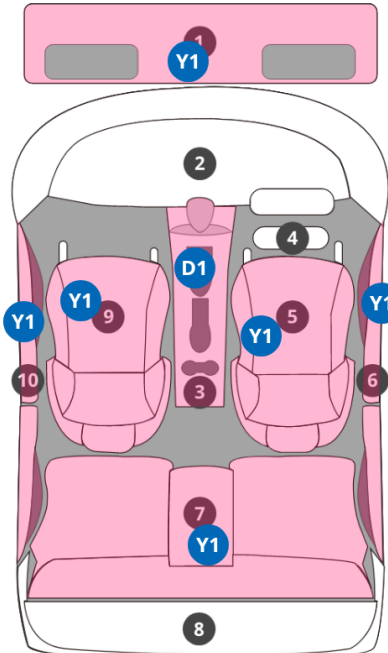
| Interior Evaluation : <span style="color: red;">A</span> | | Exterior Evaluation : <span style="color: red;">C</span> | |
| <p><b>Remarks</b></p> <p>(L) Front Seat - Grime - Minimal / (R) Front Seat - Grime - Minimal / Rear Seat - Grime - Minimal / Ceiling - Grime - Minimal / (L) Front Trim - Grime - Minimal / (R) Front Trim - Grime - Minimal / Console, Switchs, Vents - Worked - Minimal</p> | | <p><b>Remarks</b></p> <p>Roof - Repair Traces - Yes / Front Panel - Dent - Small / (L) Front Fender, Molding - Scratch - Minimal / (L) Front Door, Molding - Scratch &amp; Dent - Minimal / (L) Rear Door, Molding - Scratch &amp; Dent - Small / (L) Step, In-panel, Side Spoiler - Scratch &amp; Dent - Small / Trunk Hood, Rear Gate - Scratch - Small / Rear Bumper, Lamps, Panels - Scratch - Small / (R) Rear Fender, Molding - Scratch &amp; Dent - Small / (R) Rear Door, Molding - Scratch &amp; Dent - Small / (R) Step, In-panel, Side Spoiler - Scratch &amp; Dent - Small / (R) Center Panel - Scratch - Minimal / (R) Front Door, Molding - Scratch &amp; Dent - Small / (R) Front Fender, Molding - Scratch &amp; Dent - Small / Front Bumper, Grille, Lamps - Scratch &amp; Dent - Small / Roof - Scratch &amp; Dent - Small / (L) Rear Fender, Molding - Scratch &amp; Dent - Small</p> | |

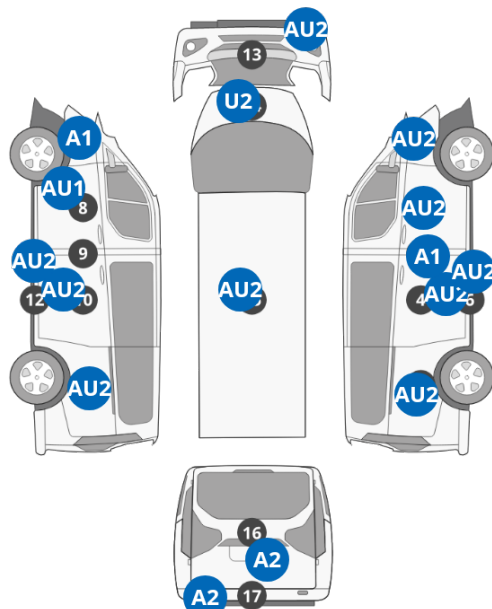
with LTO plate, with warranty & manual booklet, with spare tire, with jack & inc tools, no reverse camera, no spare key, scratches on taillight.
