## General Information

| Make | Toyota | Model | Innova |
| YOM | 2023 | Odo Meter Reading | 29,986 |
| Registration No. | DBI5041 | Chassis No. | PA2JA8EM4P0126108 |

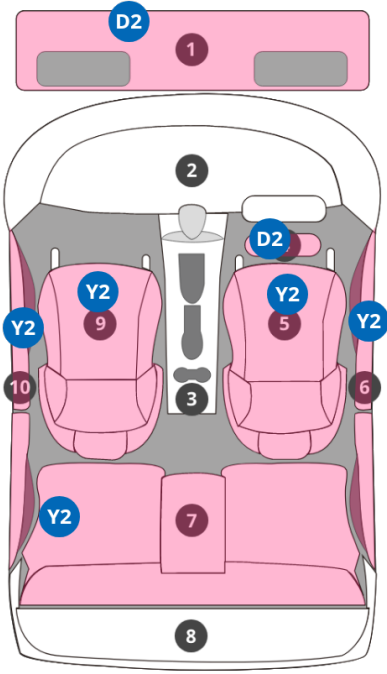
| <b>Remarks</b><br>(R) Front Trim - Grime - Small / (L) Front Trim - Grime - Small / (L) Front Seat - Grime - Small / (R) Front Seat - Grime - Small / Ceiling - Crinkle - Small / Rear Seat - Grime - Small / (L) Front Floor Mat - Worked - Small | <b>Remarks</b><br>(L) Rear Fender - Repair Traces - Yes / (R) Front Fender, Molding - Scratch - Medium / (R) Step, In-panel, Side Spoiler - Scratch & Dent - Large / (R) Rear Door, Molding - Scratch & Dent - Large / (R) Front Door, Molding - Scratch - Small / (R) Rear Fender, Molding - Scratch - Small / Rear Bumper, Lamps, Panels - Scratch - Large / Trunk Hood, Rear Gate - Scratch - Small / (L) Rear Fender, Molding - Scratch - Small / (L) Rear Door, Molding - Scratch & Dent - Medium / (L) Step, In-panel, Side Spoiler - Scratch - Small / (L) Front Door, Molding - Scratch - Small / (L) Mirror - Scratch - Small / (L) Front Fender, Molding - Scratch - Minimal / Front Bumper, Grille, Lamps - Scratch & Dent - Medium / Bonnet, Headlight - Scratch - Minimal / Roof - Scratch - Small |
