## General Information

| Make | Toyota | Model | Vios |
| Registration No. | NKE7280 | Chassis No. | PA1B18F32R4264045 |

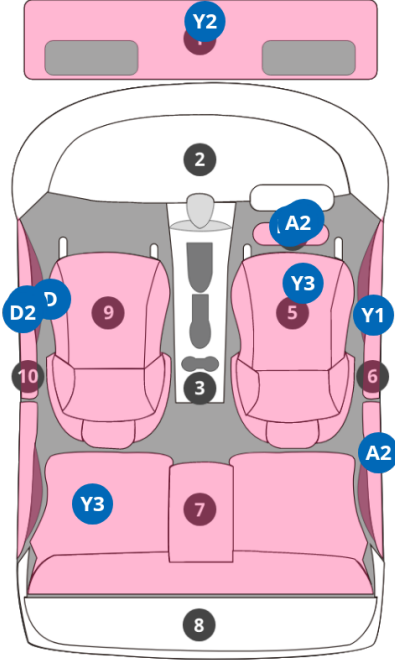
| Interior Evaluation : <b>C</b> | Exterior Evaluation : <b>D</b> |
| <p><b>Remarks</b></p> <p>(R) Front Seat - Grime - Medium / Rear Seat - Grime - Medium / (L) Front Seat - Worn - Yes / (L) Front Trim - Grime - Small / (L) Front Trim - Worked - Small / (R) Front Trim - Grime - Minimal / Ceiling - Grime - Small / (L) Front Floor Mat - Cut, Crack - Small / (L) Front Floor Mat - Worked - Small / Carpet - Worn, Scratch, Cut, Crack - Small / (R) Rear Trim - Cut, Crack - Small</p> | <p><b>Remarks</b></p> <p>Trunk Hood, Rear Gate - Repair Traces - Yes / (R) Front Fender, Molding - Repair mark - Yes / (R) Mirror - Scratch - Small / (R) Front Fender, Molding - Scratch - Minimal / (R) Front Door, Molding - Scratch - Minimal / (R) Rear Door, Molding - Scratch - Minimal / (R) Rear Fender, Molding - Scratch - Small / Rear Bumper, Lamps, Panels - Repair mark - Yes / Rear Bumper, Lamps, Panels - Crack, Gap - Medium / Trunk Hood, Rear Gate - Crack, Gap - Medium / (L) Rear Fender, Molding - Scratch - Minimal / (L) Rear Door, Molding - Scratch - Small / (L) Front Door, Molding - Scratch - Small / (L) Mirror - Scratch - Minimal / (L) Front Fender, Molding - Scratch - Small / Front Bumper, Grille, Lamps - Repair mark - Yes / Front Bumper, Grille, Lamps - Scratch - Minimal / Bonnet, Headlight - Dent - Small / Roof - Scratch - Small</p> |

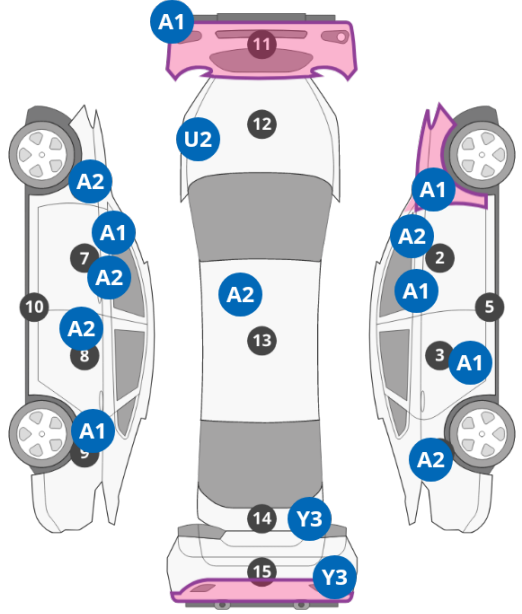
| Inspector Notes |
|---|
| with warranty booklet, jack and tools, with spare tire, with LTO plate, scratched and cracked tail light |
