## General Information

| Make | Toyota | Model | Vios |
| YOM | 2022 | Odo Meter Reading | 48,866 |
| Registration No. | NIC6371 | Chassis No. | PA1B18F38N4180872 |

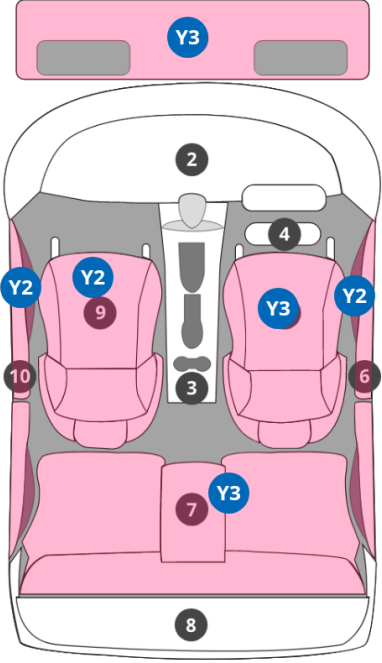
| Interior Evaluation : <b>B</b> | Exterior Evaluation : <b>D</b> |
|---|---|
| <p><b>Remarks</b><br/>(R) Front Seat - Grime - Medium / (R) Front Trim - Grime - Small / Rear Seat - Grime - Medium / (L) Front Trim - Grime - Small / (L) Front Seat - Grime - Small / Ceiling - Grime - Medium</p> | <p><b>Remarks</b><br/>(L) Rear Fender, Molding - Dent - Small / (L) Rear Door, Molding - Scratch - Small / Front Bumper, Grille, Lamps - Scratch - Large / (L) Front Fender, Molding - Dent - Small / (R) Front Fender, Molding - Crack, Gap - Small / (R) Front Door, Molding - Scratch - Small / (R) Step, In-panel, Side Spoiler - Dent - Minimal / (R) Rear Door, Molding - Scratch - Small / (R) Rear Fender, Molding - Scratch - Medium / Rear Bumper, Lamps, Panels - Scratch - Large / Trunk Hood, Rear Gate - Scratch - Minimal / (L) Front Door, Molding - Scratch - Minimal / Bonnet, Headlight - Scratch - Minimal / Roof - Dent - Minimal</p> |
