## General Information

| Make | Toyota | Model | Vios |
| YOM | 2024 | Odo Meter Reading | 55,749 |
| Registration No. | NFR5228 | Chassis No. | PA1B18F34R4253130 |

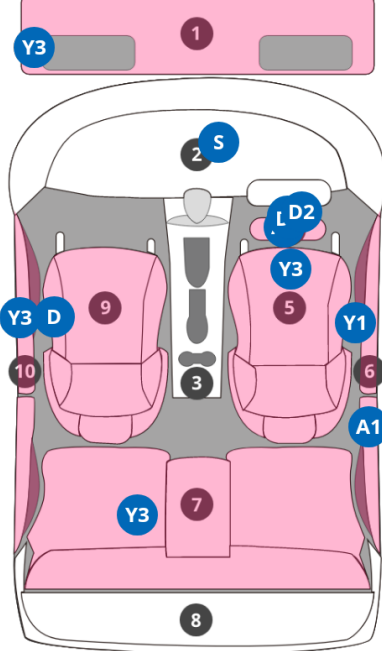
| Interior Evaluation : <b>D</b> | Exterior Evaluation : <b>E</b> |
|---|---|
| <p><b>Remarks</b></p> <p>(R) Front Seat - Grime - Medium / (L) Front Seat - Worn - Yes / (L) Front Floor Mat - Cut, Crack - Large / Overall Interior - Smell - Yes / (L) Front Trim - Grime - Medium / Ceiling - Grime - Medium / (L) Front Floor Mat - Worked - Small / Rear Seat - Grime - Medium / (R) Rear Trim - Cut, Crack - Minimal / (R) Front Trim - Grime - Minimal / (R) Front Floor Mat - Worked - Small / Mat Other - Worked - Small</p> | <p><b>Remarks</b></p> <p>(R) Front Fender, Molding - Scratch - Small / (R) Mirror - Scratch - Small / (R) Step, In-panel, Side Spoiler - Scratch &amp; Dent - Medium / (R) Front Door, Molding - Scratch &amp; Dent - Large / (R) Rear Door, Molding - Scratch &amp; Dent - Medium / (R) Rear Fender, Molding - Scratch - Small / Rear Bumper, Lamps, Panels - Scratch - Large / Trunk Hood, Rear Gate - Scratch &amp; Dent - Small / (L) Rear Fender, Molding - Scratch &amp; Dent - Medium / (L) Rear Door, Molding - Scratch &amp; Dent - Large / (L) Front Door, Molding - Scratch &amp; Dent - Medium / (L) Mirror - Scratch - Small / Member (Bolted) - Dent - Yes / (L) Front Fender, Molding - Scratch - Small / Front Bumper, Grille, Lamps - Scratch - Small / Bonnet, Headlight - Scratch - Small / Roof - Scratch &amp; Dent - Minimal</p> |

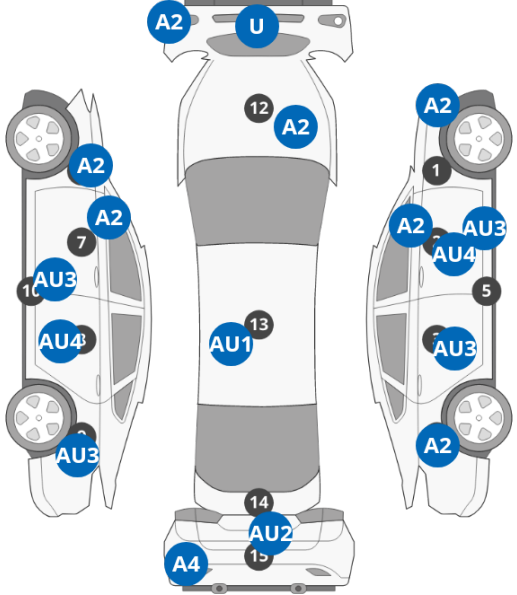
| Inspector Notes |
|---|
| no warranty booklet, with jack, incomplete tools, with spare tire, with LTO plate, scratches on tail light, plate light issue, with pending appreciation disregard traffic light 1000 |
