General Information

Make	Toyota	Model	Vios
YOM	2024	Odo Meter Reading	14,392
Registration No.	NFR4144	Chassis No.	PA1B18F36R4248415
CC	1.3	Transmission	CVT
Fuel Type	Gas	Type of Body	Sedan
Colour	Red Mica Metallic

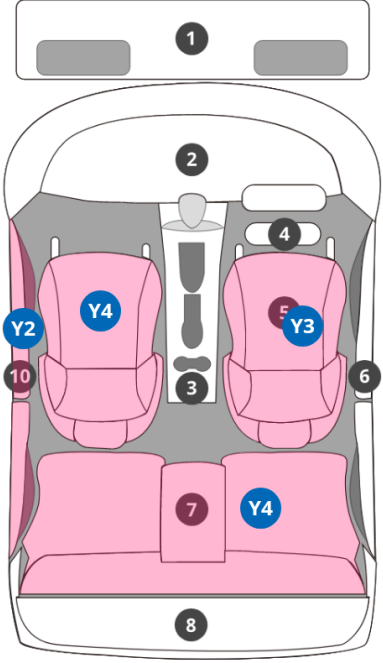
<p>a : Cut, Fray d : Loose, Deformed k : Animal Hair s : Smell t : Cigarette Burns x : Defective y : Stain</p>

<p>A : Scratch AU : Scratch & Dent B : Modified C : Corrosion G : Stone chip P : Faded S : Rust SC : Rust & Corrosion U : Dent X : Defective Y : Crack, Gap</p>
<p>Remarks Rear Seat - Grime - Large / (R) Front Seat - Grime - Medium / (L) Front Seat - Grime - Large / (L) Front Trim - Grime - Small</p>	<p>Remarks Front Bumper, Grille, Lamps - Scratch - Large / (L) Front Fender, Molding - Scratch - Medium / (L) Front Door, Molding - Scratch & Dent - Large / (L) Rear Door, Molding - Scratch - Medium / (L) Rear Fender, Molding - Scratch - Medium / Rear Bumper, Lamps, Panels - Scratch - Large / Trunk Hood, Rear Gate - Scratch & Dent - Medium / (R) Rear Door, Molding - Scratch & Dent - Medium / (R) Front Door, Molding - Scratch - Medium / (R) Front Fender, Molding - Scratch & Dent - Small / (R) Step, In-panel, Side Spoiler - Scratch & Dent - Large</p>
