## General Information

| Make | Toyota | Model | Vios |

## Body / Panel Condition

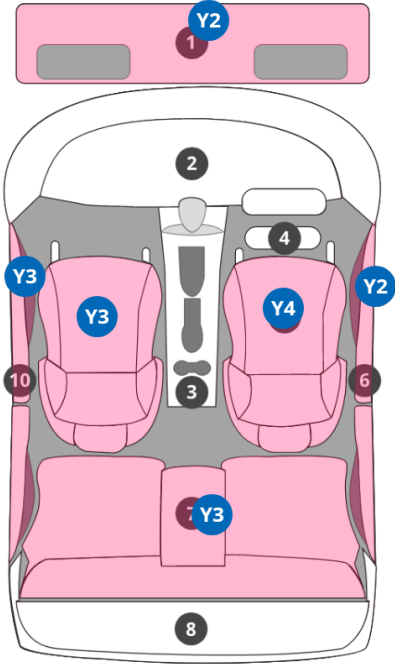
| Interior Evaluation : <b>C</b> | Exterior Evaluation : <b>E</b> |
|---|---|
| <p><b>Remarks</b><br/>(R) Front Seat - Grime - Large / (R) Front Trim - Grime - Small / Rear Seat - Grime - Medium / (L) Front Trim - Grime - Medium / (L) Front Seat - Grime - Medium / Ceiling - Grime - Small</p> | <p><b>Remarks</b><br/>(R) Rear Fender, Molding - Scratch - Medium / (R) Front Door, Molding - Scratch - Minimal / (R) Front Fender, Molding - Scratch - Small / Bonnet, Headlight - Scratch &amp; Dent - Medium / Front Bumper, Grille, Lamps - Scratch - Small / (L) Front Fender, Molding - Scratch &amp; Dent - Small / (L) Mirror - Scratch - Small / (L) Front Door, Molding - Scratch &amp; Dent - Small / (L) Step, In-panel, Side Spoiler - Scratch - Medium / (L) Rear Door, Molding - Scratch &amp; Dent - Medium / (L) Rear Fender, Molding - Scratch - Medium / Trunk Hood, Rear Gate - Scratch - Small / Rear Bumper, Lamps, Panels - Scratch - Medium / Roof - Dent - Small / (R) Rear Door, Molding - Scratch - Small</p> |
