General Information

Make	Toyota	Model	Vios
YOM	2025	Odo Meter Reading	26,384
Registration No.	NKK3197	Chassis No.	PA1B18F35R4270521
CC	1.3	Transmission	CVT
Fuel Type	Gas	Type of Body	Sedan
Colour	Blue

Body / Panel Condition

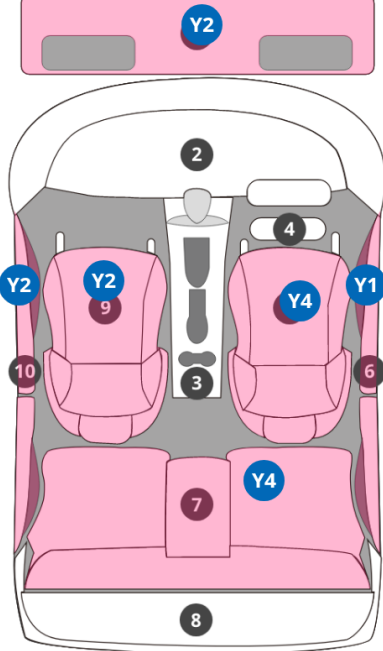
<p>a : Cut, Fray d : Loose, Deformed k : Animal Hair s : Smell t : Cigarette Burns x : Defective y : Stain</p>

<p>A : Scratch AU : Scratch & Dent B : Modified C : Corrosion G : Stone chip P : Faded S : Rust SC : Rust & Corrosion U : Dent X : Defective Y : Crack, Gap</p>
<p>Remarks (R) Front Seat - Grime - Large / (R) Front Trim - Grime - Minimal / Rear Seat - Grime - Large / (L) Front Trim - Grime - Small / (L) Front Seat - Grime - Small / Ceiling - Grime - Small</p>	<p>Remarks (R) Front Door - Repair Traces - Yes / (R) Front Fender - Repair Traces - Yes / Bonnet - Repair Traces - Yes / (L) Front Fender - Repair Traces - Yes / (L) Front Fender, Molding - Scratch - Minimal / (L) Rear Fender, Molding - Scratch - Minimal / Rear Bumper, Lamps, Panels - Scratch - Minimal / (R) Rear Fender, Molding - Scratch - Minimal / (R) Rear Door, Molding - Scratch & Dent - Large / (R) Front Door, Molding - Scratch - Small / Bonnet, Headlight - Scratch & Dent - Large / Front Bumper, Grille, Lamps - Scratch - Large / Trunk Hood, Rear Gate - Scratch - Minimal / (L) Front Door, Molding - Scratch - Minimal / (L) Rear Door, Molding - Scratch - Minimal / Roof - Dent - Small / (R) Front Door, Molding - Repair mark - Yes</p>
