## General Information

| Make | Toyota | Model | Vios |
| Registration No. | NJF2071 | Chassis No. | PA1B18F32R4277801 |

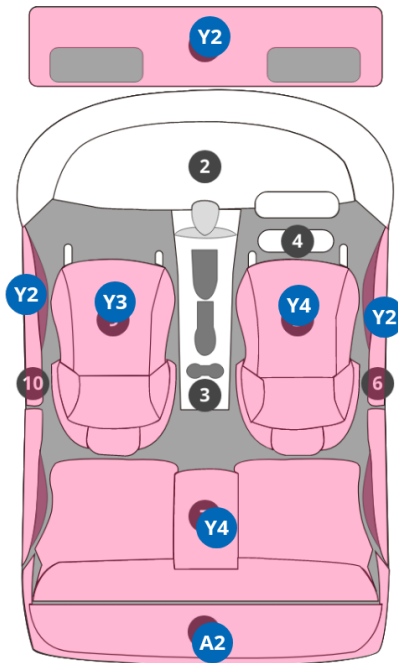
| Interior Evaluation : <b>C</b> | Exterior Evaluation : <b>E</b> |
|---|---|
| <p><b>Remarks</b><br/>(R) Front Seat - Grime - Large / (R) Front Trim - Grime - Small / Rear Seat - Grime - Large / Trunk Room - Worn, Scratch, Cut, Crack - Small / (L) Front Trim - Grime - Small / (L) Front Seat - Grime - Medium / Ceiling - Grime - Small</p> | <p><b>Remarks</b><br/>(L) Rear Fender - Repair Traces - Yes / Roof - Repair Traces - Yes / Roof - Dent - Small / (L) Rear Door, Molding - Scratch - Large / (L) Rear Fender, Molding - Repair mark - Yes / Roof - Repair mark - Yes / (L) Front Door, Molding - Scratch - Large / (L) Front Fender, Molding - Scratch - Small / Bonnet, Headlight - Scratch - Medium / Front Bumper, Grille, Lamps - Scratch - Medium / (R) Front Fender, Molding - Scratch - Small / (R) Front Door, Molding - Scratch &amp; Dent - Large / (R) Step, In-panel, Side Spoiler - Scratch &amp; Dent - Medium / (R) Rear Door, Molding - Scratch - Small / (R) Rear Fender, Molding - Scratch - Medium / Rear Bumper, Lamps, Panels - Scratch - Small / Trunk Hood, Rear Gate - Scratch - Small / (L) Rear Fender, Molding - Scratch - Small</p> |
