## General Information

| Make | Toyota | Model | Rush |
| Registration No. | NHJ7335 | Chassis No. | MHKE8FF3PPK056206 |

## Body / Panel Condition

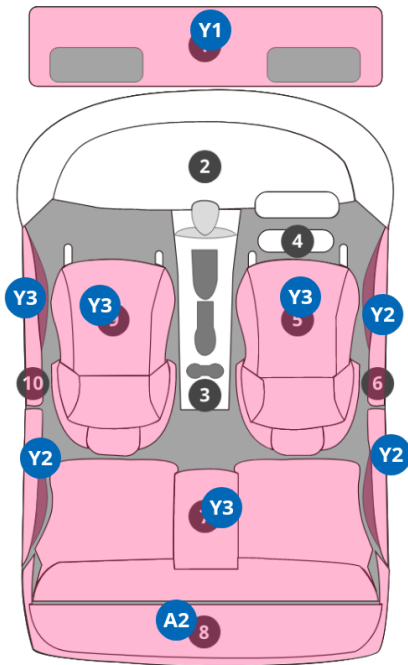
| Interior Evaluation : <span style="color: red;">C</span> | Exterior Evaluation : <span style="color: red;">E</span> |
|---|---|
| <b>Remarks</b><br>(R) Front Seat - Grime - Medium / (R) Front Trim - Grime - Small / Rear Seat - Grime - Medium / (R) Rear Trim - Grime - Small / (L) Rear Trim - Grime - Small / (L) Front Trim - Grime - Medium / (L) Front Seat - Grime - Medium / Ceiling - Grime - Minimal / Trunk Room - Worn, Scratch, Cut, Crack - Small | <b>Remarks</b><br>(L) Rear Door, Molding - Scratch - Medium / (L) Rear Fender, Molding - Scratch - Medium / (L) Front Door, Molding - Scratch - Medium / (L) Mirror - Scratch - Minimal / (L) Front Fender, Molding - Scratch - Small / Front Bumper, Grille, Lamps - Scratch - Medium / Bonnet, Headlight - Scratch - Small / (R) Front Fender, Molding - Scratch - Small / (R) Mirror - Scratch - Small / (R) Front Door, Molding - Scratch - Large / (R) Rear Door, Molding - Scratch - Medium / (R) Rear Fender, Molding - Scratch - Small / Trunk Hood, Rear Gate - Scratch - Large / Rear Bumper, Lamps, Panels - Scratch - Large / Roof - Scratch - Minimal |
