General Information

Make	Toyota	Model	Vios
YOM	2024	Odo Meter Reading	41,188
Registration No.	DBO7141	Chassis No.	PA1B18F37R4257012
CC	1.3	Transmission	CVT
Fuel Type	Gas	Type of Body	Sedan
Colour	Blue

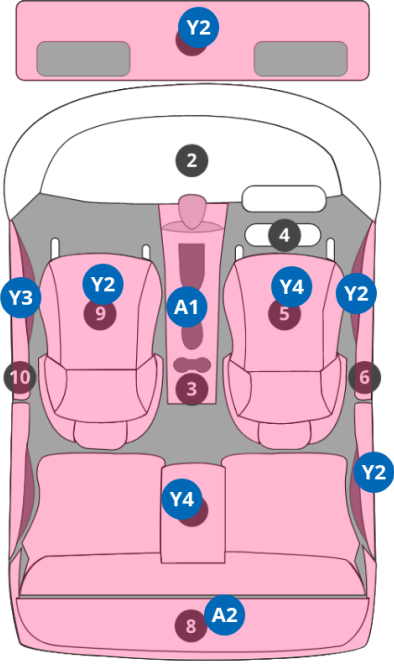
Interior Evaluation : C	Exterior Evaluation : E

<p>a : Cut, Fray d : Loose, Deformed k : Animal Hair s : Smell t : Cigarette Burns x : Defective y : Stain</p>

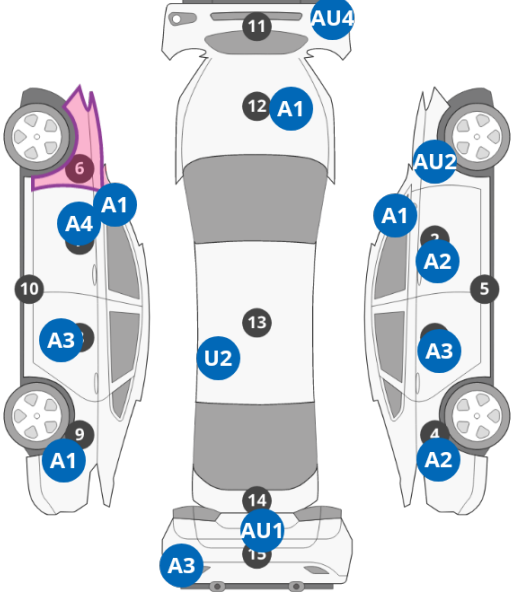
<p>A : Scratch AU : Scratch & Dent B : Modified C : Corrosion G : Stone chip P : Faded S : Rust SC : Rust & Corrosion U : Dent X : Defective Y : Crack, Gap</p>
<p>Remarks (R) Front Seat - Grime - Large / (R) Front Trim - Grime - Small / Rear Seat - Grime - Large / (R) Rear Trim - Grime - Small / Trunk Room - Worn, Scratch, Cut, Crack - Small / (L) Front Trim - Grime - Medium / (L) Front Seat - Grime - Small / Ceiling - Grime - Small / Console, Switches, Vents - Worn, Scratch, Cut, Crack - Minimal</p>	<p>Remarks (L) Front Fender - Repair Traces - Yes / (L) Front Fender, Molding - Repair mark - Yes / (L) Mirror - Scratch - Minimal / (L) Front Door, Molding - Scratch - Large / (L) Rear Door, Molding - Scratch - Medium / (L) Rear Fender, Molding - Scratch - Minimal / Roof - Dent - Small / Front Bumper, Grille, Lamps - Scratch & Dent - Large / (R) Front Fender, Molding - Scratch & Dent - Small / Bonnet, Headlight - Scratch - Minimal / (R) Mirror - Scratch - Minimal / (R) Front Door, Molding - Scratch - Small / (R) Rear Door, Molding - Scratch - Medium / (R) Rear Fender, Molding - Scratch - Small / Rear Bumper, Lamps, Panels - Scratch - Medium / Trunk Hood, Rear Gate - Scratch & Dent - Minimal</p>
