General Information

Make	Toyota	Model	Vios
YOM	2024	Odo Meter Reading	42,277
Registration No.	NHU2298	Chassis No.	PA1B18F37P4235220
CC	1.3	Transmission	CVT
Fuel Type	Gas	Type of Body	Sedan
Colour	Black

Body / Panel Condition

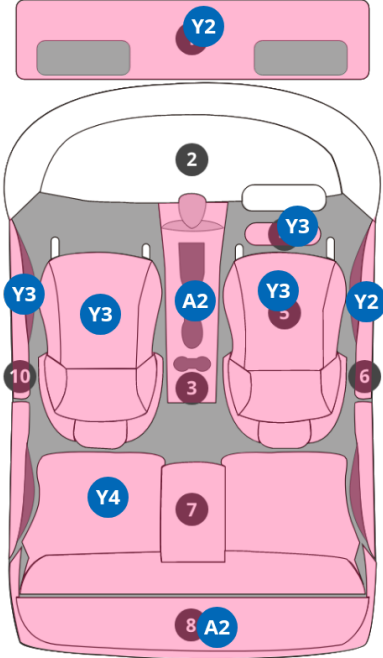
Interior Evaluation : C	Exterior Evaluation : E

<p>a : Cut, Fray d : Loose, Deformed k : Animal Hair s : Smell t : Cigarette Burns x : Defective y : Stain</p>

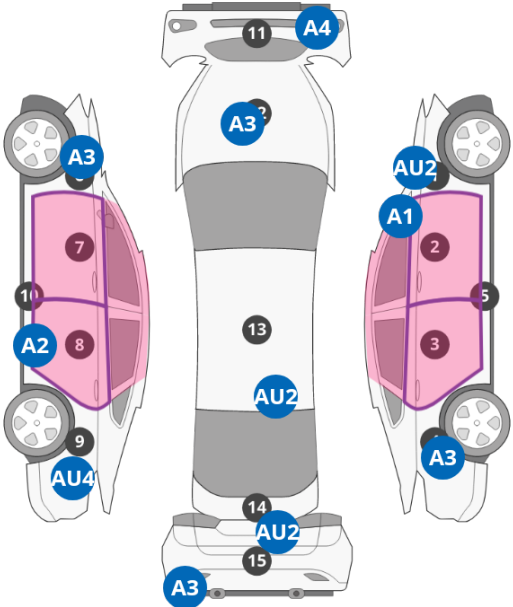
<p>A : Scratch AU : Scratch & Dent B : Modified C : Corrosion G : Stone chip P : Faded S : Rust SC : Rust & Corrosion U : Dent X : Defective Y : Crack, Gap</p>
<p>Remarks (R) Front Seat - Grime - Medium / (R) Front Trim - Grime - Small / Rear Seat - Grime - Large / (L) Front Trim - Grime - Medium / (L) Front Seat - Grime - Medium / (L) Front Floor Mat - Grime - Medium / Ceiling - Grime - Small / Console, Switches, Vents - Worn, Scratch, Cut, Crack - Small / Trunk Room - Worn, Scratch, Cut, Crack - Small</p>	<p>Remarks (R) Front Door - Repair Traces - Yes / (L) Front Fender - Repair Traces - Yes / (L) Front Door - Repair Traces - Yes / (L) Rear Door - Repair Traces - Yes / (L) Rear Fender - Repair Traces - Yes / (R) Rear Door - Repair Traces - Yes / Roof - Repair Traces - Yes / (L) Front Fender, Molding - Scratch - Medium / Bonnet, Headlight - Scratch - Medium / Front Bumper, Grille, Lamps - Scratch - Large / (R) Front Fender, Molding - Scratch & Dent - Small / (R) Mirror - Scratch - Minimal / (R) Front Door, Molding - Repair mark - Yes / (R) Rear Door, Molding - Repair mark - Yes / (L) Front Door, Molding - Repair mark - Yes / (L) Rear Door, Molding - Repair mark - Yes / (R) Rear Fender, Molding - Scratch - Medium / Trunk Hood, Rear Gate - Scratch & Dent - Small / Rear Bumper, Lamps, Panels - Scratch - Medium / (L) Rear Fender, Molding - Scratch & Dent - Large / (L) Step, In-panel, Side Spoiler - Scratch - Small / Roof - Scratch & Dent - Small</p>
