General Information

Make	Toyota	Model	Vios
YOM	2025	Odo Meter Reading	56,331
Registration No.	DBQ1214	Chassis No.	PA1B18F39R4267556
CC	1.3	Transmission	CVT
Fuel Type	Gas	Type of Body	Sedan
Colour	Red

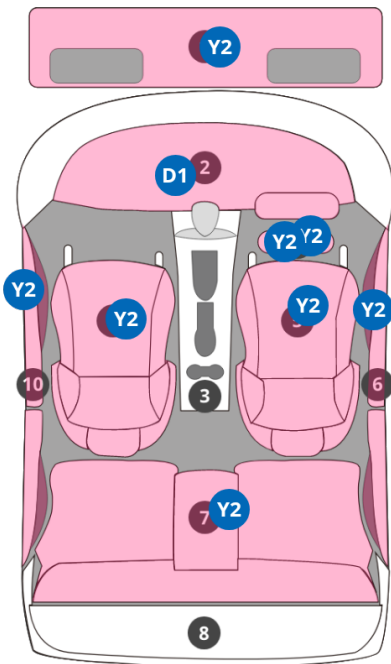
Interior Evaluation : B	Exterior Evaluation : C

<p>a : Cut, Fray d : Loose, Deformed k : Animal Hair s : Smell t : Cigarette Burns x : Defective y : Stain</p>

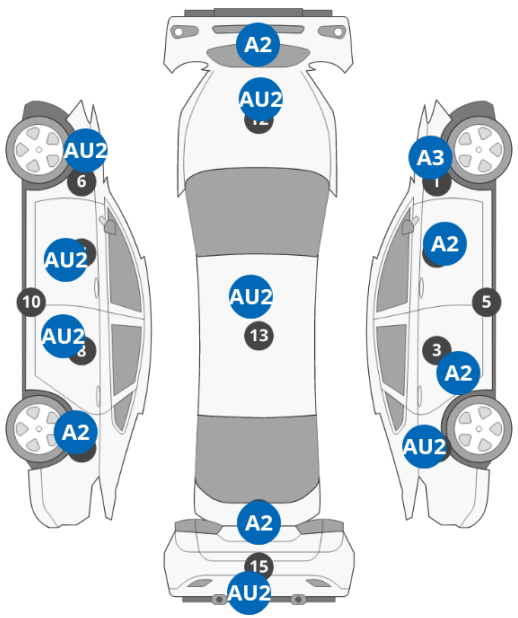
<p>A : Scratch AU : Scratch & Dent B : Modified C : Corrosion G : Stone chip P : Faded S : Rust SC : Rust & Corrosion U : Dent X : Defective Y : Crack, Gap</p>
<p>Remarks (L) Front Floor Mat - Grime - Small / (R) Front Floor Mat - Grime - Small / Dashboard - Worked - Minimal / (R) Front Trim - Grime - Small / (L) Front Trim - Grime - Small / Rear Seat - Grime - Small / (R) Front Seat - Grime - Small / (L) Front Seat - Grime - Small / Ceiling - Grime - Small</p>	<p>Remarks (R) Rear Fender - Repair Traces - Yes / (R) Rear Door - Repair Traces - Yes / (L) Rear Fender, Molding - Scratch - Small / Trunk Hood, Rear Gate - Scratch - Small / Rear Bumper, Lamps, Panels - Scratch & Dent - Small / (L) Rear Door, Molding - Scratch & Dent - Small / (L) Front Door, Molding - Scratch & Dent - Small / (L) Front Fender, Molding - Scratch & Dent - Small / Bonnet, Headlight - Scratch & Dent - Small / (R) Front Fender, Molding - Scratch - Medium / (R) Rear Door, Molding - Scratch - Small / (R) Rear Fender, Molding - Scratch & Dent - Small / Roof - Scratch & Dent - Small / Front Bumper, Grille, Lamps - Scratch - Small / (R) Front Door, Molding - Scratch - Small</p>
