General Information

Make	Toyota	Model	Vios
YOM	2023	Odo Meter Reading	122,964
Registration No.	NHJ4777	Chassis No.	PA1B18F30P4218601
CC	1.3	Transmission	CVT
Fuel Type	Gas	Type of Body	Sedan
Colour	Black

Body / Panel Condition

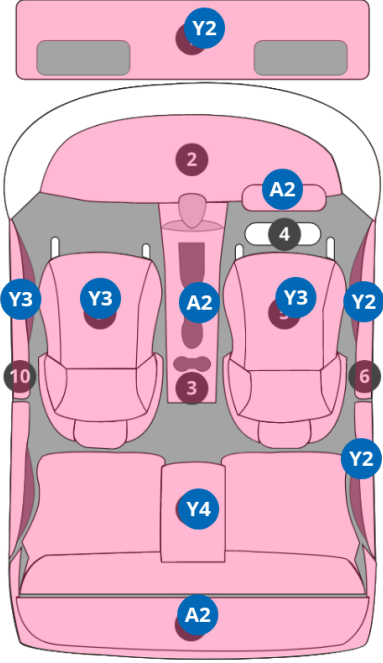
Interior Evaluation : C	Exterior Evaluation : E
<div style="text-align: center;">

</div> <p>a : Cut, Fray d : Loose, Deformed k : Animal Hair s : Smell t : Cigarette Burns x : Defective y : Stain</p>	<div style="text-align: center;">

</div> <p>A : Scratch AU : Scratch & Dent B : Modified C : Corrosion G : Stone chip P : Faded S : Rust SC : Rust & Corrosion U : Dent X : Defective Y : Crack, Gap</p>
<p>Remarks (R) Front Seat - Grime - Medium / (R) Front Trim - Grime - Small / Rear Seat - Grime - Large / (R) Rear Trim - Grime - Small / (L) Front Trim - Grime - Medium / (L) Front Seat - Grime - Medium / Steering Wheel - Worn, Peel, Crack - Small / Ceiling - Grime - Small / Trunk Room - Worn, Scratch, Cut, Crack - Small / Knobs - Worn, Peel, Crack - Small</p>	<p>Remarks (R) Front Door - Repair Traces - Yes / (R) Front Fender - Repair Traces - Yes / Bonnet - Repair Traces - Yes / (L) Front Fender - Repair Traces - Yes / (L) Front Door - Repair Traces - Yes / (L) Rear Door - Repair Traces - Yes / (L) Rear Fender - Repair Traces - Yes / Trunk Hood, Rear Gate - Repair Traces - Yes / (R) Rear Fender - Repair Traces - Yes / (R) Rear Door - Repair Traces - Yes / Roof - Repair Traces - Yes / (L) Rear Door, Molding - Scratch - Medium / (L) Front Door, Molding - Scratch - Small / (L) Mirror - Scratch - Minimal / (L) Rear Fender, Molding - Scratch - Small / (L) Front Fender, Molding - Scratch - Medium / Bonnet, Headlight - Scratch - Medium / Front Bumper, Grille, Lamps - Scratch & Dent - Large / (R) Front Fender, Molding - Repair mark - Yes / (R) Front Fender, Molding - Scratch & Dent - Medium / (R) Mirror - Scratch - Minimal / (R) Front Door, Molding - Scratch & Dent - Medium / (R) Rear Door, Molding - Scratch - Medium / (R) Rear Fender, Molding - Scratch & Dent - Medium / Trunk Hood, Rear Gate - Scratch & Dent - Large / Rear Bumper, Lamps, Panels - Scratch - Medium / Roof - Scratch - Small / (L) Step, In-panel, Side Spoiler - Dent - Medium</p>
