## General Information

<b>Make</b>	Toyota	<b>Model</b>	Vios
<b>YOM</b>	2024	<b>Odo Meter Reading</b>	2,421
<b>Registration No.</b>	NHM1449	<b>Chassis No.</b>	PA1B18F33P4236297
<b>CC</b>	1.3	<b>Transmission</b>	CVT
<b>Fuel Type</b>	Gas	<b>Type of Body</b>	Sedan
<b>Colour</b>	Red Mica Metallic

## Body / Panel Condition

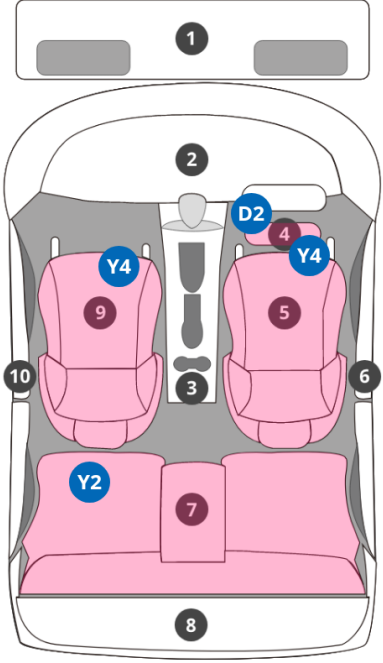
<b>Interior Evaluation :</b> <span style="float: right; color: red; font-weight: bold;">C</span>	<b>Exterior Evaluation :</b> <span style="float: right; color: red; font-weight: bold;">E</span>

<p><b>a</b> : Cut, Fray <b>d</b> : Loose, Deformed <b>k</b> : Animal Hair <b>s</b> : Smell <b>t</b> : Cigarette Burns <b>x</b> : Defective <b>y</b> : Stain</p>

<p><b>A</b> : Scratch <b>AU</b> : Scratch &amp; Dent <b>B</b> : Modified <b>C</b> : Corrosion <b>G</b> : Stone chip <b>P</b> : Faded <b>S</b> : Rust <b>SC</b> : Rust &amp; Corrosion <b>U</b> : Dent <b>X</b> : Defective <b>Y</b> : Crack, Gap</p>
<p><b>Remarks</b> (L) Front Seat - Grime - Large / (R) Front Seat - Grime - Large / (L) Front Floor Mat - Worked - Small / Rear Seat - Grime - Small</p>	<p><b>Remarks</b> (L) Front Door, Molding - Scratch - Large / (L) Front Fender, Molding - Scratch - Large / (L) Rear Door, Molding - Scratch - Large / (L) Rear Fender, Molding - Scratch - Medium / Trunk Hood, Rear Gate - Scratch - Medium / Rear Bumper, Lamps, Panels - Scratch - Medium / (R) Rear Door, Molding - Scratch - Medium / Front Bumper, Grille, Lamps - Scratch - Medium / (R) Front Door, Molding - Scratch - Small / (R) Front Fender, Molding - Scratch - Small / Bonnet, Headlight - Scratch - Small / (R) Rear Fender, Molding - Scratch - Small</p>
