General Information

Make	Toyota	Model	Vios
YOM	2024	Odo Meter Reading	5,480
Registration No.	NKE3988	Chassis No.	PA1B18F38R4259156
CC	1.3	Transmission	CVT
Fuel Type	Gas	Type of Body	Sedan
Colour	Red Mica Metallic

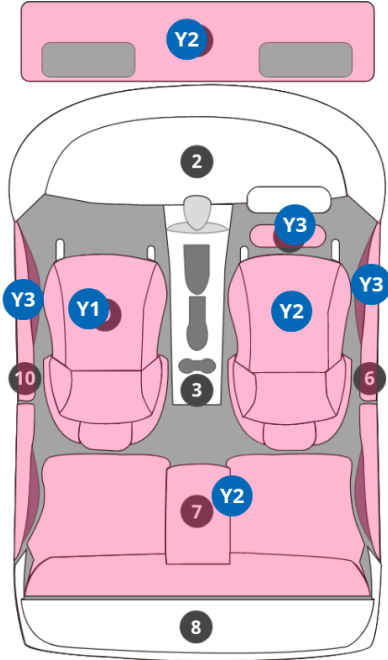
Interior Evaluation : C	Exterior Evaluation : E

<p>a : Cut, Fray d : Loose, Deformed k : Animal Hair s : Smell t : Cigarette Burns x : Defective y : Stain</p>

<p>A : Scratch AU : Scratch & Dent B : Modified C : Corrosion G : Stone chip P : Faded S : Rust SC : Rust & Corrosion U : Dent X : Defective Y : Crack, Gap</p>
<p>Remarks (R) Front Seat - Grime - Small / (R) Front Trim - Grime - Medium / Rear Seat - Grime - Small / (L) Front Trim - Grime - Medium / (L) Front Seat - Grime - Minimal / (L) Front Floor Mat - Grime - Medium / Ceiling - Grime - Small</p>	<p>Remarks (L) Front Fender, Molding - Scratch - Small / Bonnet, Headlight - Scratch - Small / Front Bumper, Grille, Lamps - Crack, Gap - Large / (R) Front Fender, Molding - Scratch & Dent - Large / (R) Mirror - Scratch - Minimal / (R) Front Door, Molding - Scratch - Large / (R) Rear Door, Molding - Scratch - Large / (R) Rear Fender, Molding - Scratch - Small / Rear Bumper, Lamps, Panels - Scratch - Large / Trunk Hood, Rear Gate - Scratch - Medium / (L) Rear Fender, Molding - Scratch - Small / (L) Rear Door, Molding - Scratch - Medium / (L) Front Door, Molding - Scratch - Small / Roof - Scratch - Small</p>
