General Information

Make	Toyota	Model	Vios
YOM	2024	Odo Meter Reading	6,875
Registration No.	NKA9430	Chassis No.	PA1B18F31R4242375
CC	1.3	Transmission	CVT
Fuel Type	Gas	Type of Body	Sedan
Colour	Red

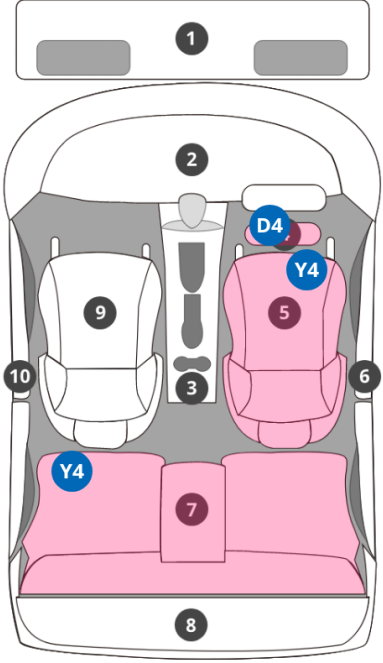
<p>a : Cut, Fray d : Loose, Deformed k : Animal Hair s : Smell t : Cigarette Burns x : Defective y : Stain</p>

<p>A : Scratch AU : Scratch & Dent B : Modified C : Corrosion G : Stone chip P : Faded S : Rust SC : Rust & Corrosion U : Dent X : Defective Y : Crack, Gap</p>
<p>Remarks (R) Front Seat - Grime - Large / Rear Seat - Grime - Large / (L) Front Floor Mat - Worked - Large</p>	<p>Remarks Bonnet - Repair Traces - Yes / (R) Rear Fender, Molding - Scratch & Dent - Large / (R) Rear Door, Molding - Scratch & Dent - Large / (R) Front Door, Molding - Scratch & Dent - Medium / Trunk Hood, Rear Gate - Crack, Gap - Large / Rear Bumper, Lamps, Panels - Scratch - Small / (L) Rear Door, Molding - Dent - Small / (L) Front Door, Molding - Scratch - Small / (L) Front Fender, Molding - Scratch - Small / Front Bumper, Grille, Lamps - Scratch & Dent - Large / Bonnet, Headlight - Scratch - Small / (R) Front Fender, Molding - Scratch - Small</p>
