General Information

Make	Toyota	Model	Vios
YOM	2024	Odo Meter Reading	9,936
Registration No.	NKA5721	Chassis No.	PA1B18F38R4244429
CC	1.3	Transmission	CVT
Fuel Type	Gas	Type of Body	Sedan
Colour	Red Mica Metallic

Body / Panel Condition

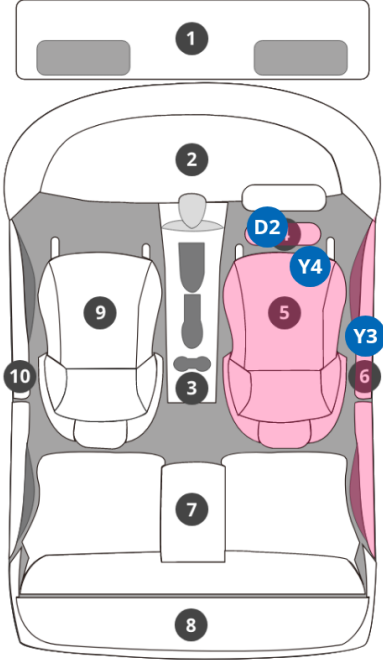
Interior Evaluation : C	Exterior Evaluation : E

<p>a : Cut, Fray d : Loose, Deformed k : Animal Hair s : Smell t : Cigarette Burns x : Defective y : Stain</p>

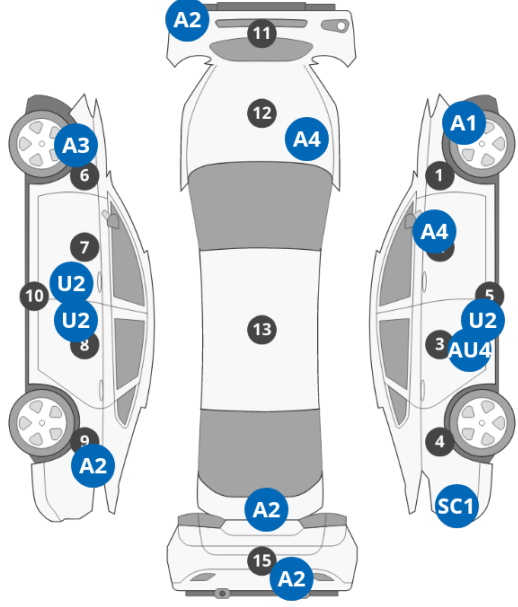
<p>A : Scratch AU : Scratch & Dent B : Modified C : Corrosion G : Stone chip P : Faded S : Rust SC : Rust & Corrosion U : Dent X : Defective Y : Crack, Gap</p>
<p>Remarks (R) Front Seat - Grime - Large / (R) Front Trim - Grime - Medium / (L) Front Floor Mat - Worked - Small</p>	<p>Remarks (R) Front Fender - Repair Traces - Yes / (L) Front Door, Molding - Dent - Small / (L) Rear Door, Molding - Dent - Small / (L) Rear Fender, Molding - Scratch - Small / Trunk Hood, Rear Gate - Scratch - Small / Rear Bumper, Lamps, Panels - Scratch - Small / (R) Rear Door, Molding - Scratch & Dent - Large / (R) Step, In-panel, Side Spoiler - Dent - Small / Bonnet, Headlight - Scratch - Large / (L) Front Fender, Molding - Scratch - Medium / (R) Front Door, Molding - Scratch - Large / (R) Rear Fender, Molding - Rust, Corrosion - Minimal / (R) Front Fender, Molding - Scratch - Minimal / Front Bumper, Grille, Lamps - Scratch - Small</p>
