General Information

Make	Toyota	Model	Vios
YOM	2024	Odo Meter Reading	24,845
Registration No.	GBE4941	Chassis No.	PA1B18F3XR4252905
CC	1.3	Transmission	CVT
Fuel Type	Gas	Type of Body	Sedan
Colour	Silver

Body / Panel Condition

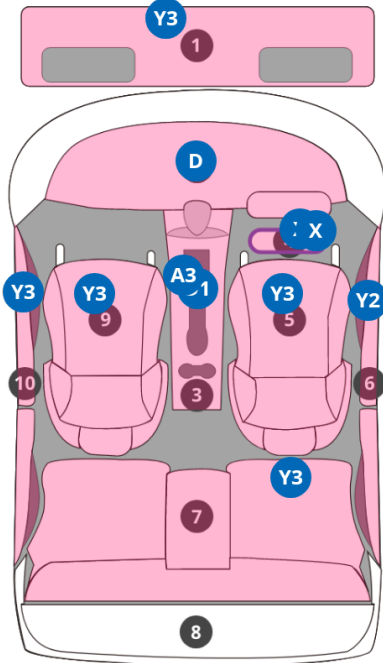
Interior Evaluation : C	Exterior Evaluation : E

<p>a : Cut, Fray d : Loose, Deformed k : Animal Hair s : Smell t : Cigarette Burns x : Defective y : Stain</p>

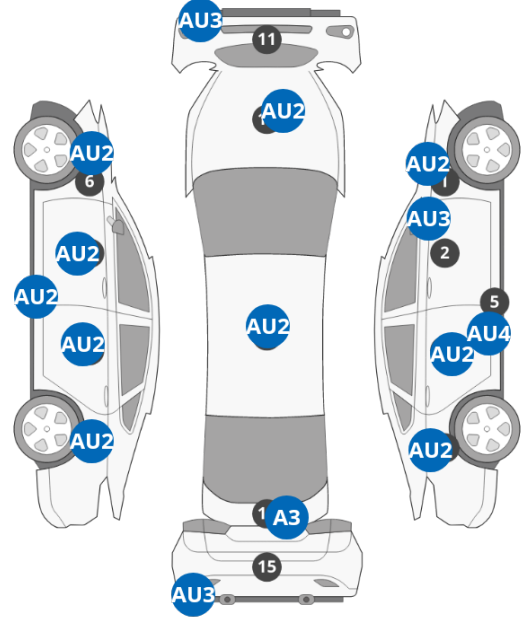
<p>A : Scratch AU : Scratch & Dent B : Modified C : Corrosion G : Stone chip P : Faded S : Rust SC : Rust & Corrosion U : Dent X : Defective Y : Crack, Gap</p>
<p>Remarks (L) Front Seat - Grime - Medium / (L) Front Trim - Grime - Medium / Rear Seat - Grime - Medium / (R) Front Seat - Grime - Medium / (R) Front Trim - Grime - Small / Ceiling - Grime - Medium / Dashboard - Traces of Adhesive Tape - Yes / Console, Switchs, Vents - Worked - Minimal / Console, Switchs, Vents - Worn, Scratch, Cut, Crack - Medium / (R) Front Floor Mat - Missing - Yes / (L) Front Floor Mat - Missing - Yes</p>	<p>Remarks Roof - Scratch & Dent - Small / (L) Front Fender, Molding - Scratch & Dent - Small / Front Bumper, Grille, Lamps - Scratch & Dent - Medium / Bonnet, Headlight - Scratch & Dent - Small / (R) Front Fender, Molding - Scratch & Dent - Small / (R) Front Door, Molding - Scratch & Dent - Medium / (R) Rear Door, Molding - Scratch & Dent - Small / (R) Step, In-panel, Side Spoiler - Scratch & Dent - Large / (R) Rear Fender, Molding - Scratch & Dent - Small / Trunk Hood, Rear Gate - Scratch - Medium / Rear Bumper, Lamps, Panels - Scratch & Dent - Medium / (L) Rear Fender, Molding - Scratch & Dent - Small / (L) Rear Door, Molding - Scratch & Dent - Small / (L) Step, In-panel, Side Spoiler - Scratch & Dent - Small / (L) Front Door, Molding - Scratch & Dent - Small</p>
