## General Information

<b>Make</b>	Toyota	<b>Model</b>	Innova
<b>YOM</b>	2024	<b>Odo Meter Reading</b>	36,212
<b>Registration No.</b>	DBM7422	<b>Chassis No.</b>	PA2JA8EM9R0137205
<b>CC</b>	2.8	<b>Transmission</b>	A/T
<b>Fuel Type</b>	Diesel	<b>Type of Body</b>	Wagon
<b>Colour</b>	Red Mica Metallic

## Body / Panel Condition

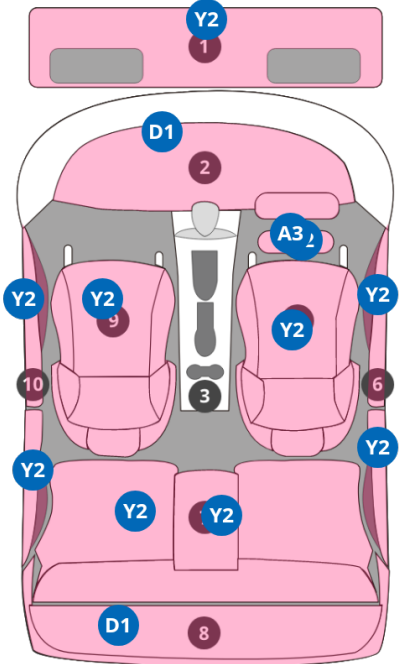
<b>Interior Evaluation :</b> <span style="color: red; font-weight: bold; font-size: 1.2em;">C</span>	<b>Exterior Evaluation :</b> <span style="color: red; font-weight: bold; font-size: 1.2em;">E</span>

<p><b>a</b> : Cut, Fray <b>d</b> : Loose, Deformed <b>k</b> : Animal Hair <b>s</b> : Smell <b>t</b> : Cigarette Burns <b>x</b> : Defective <b>y</b> : Stain</p>

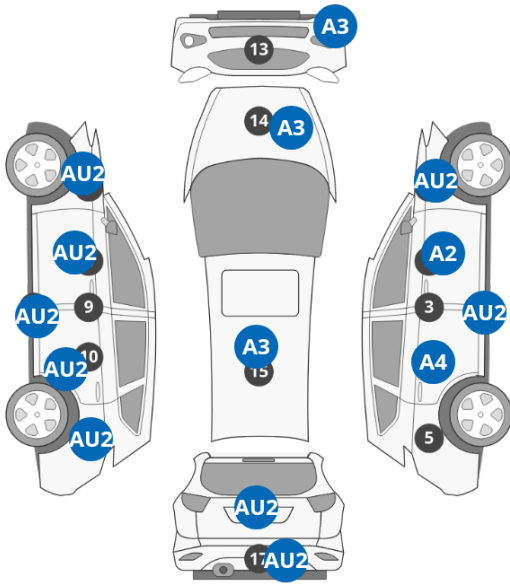
<p><b>A</b> : Scratch <b>AU</b> : Scratch &amp; Dent <b>B</b> : Modified <b>C</b> : Corrosion <b>G</b> : Stone chip <b>P</b> : Faded <b>S</b> : Rust <b>SC</b> : Rust &amp; Corrosion <b>U</b> : Dent <b>X</b> : Defective <b>Y</b> : Crack, Gap</p>
<p><b>Remarks</b> Ceiling - Grime - Small / (L) Front Trim - Grime - Small / (R) Front Trim - Grime - Small / (L) Rear Trim - Grime - Small / (R) Rear Trim - Grime - Small / (L) Front Seat - Grime - Small / (R) Front Seat - Grime - Small / (R) Front Floor Mat - Grime - Small / (L) Front Floor Mat - Cut, Crack - Medium / Trim Other - Grime - Small / Rear Seat - Grime - Small / Trunk Room - Worked - Minimal / Dashboard - Worked - Minimal</p>	<p><b>Remarks</b> (L) Front Fender, Molding - Scratch &amp; Dent - Small / (L) Front Door, Molding - Scratch &amp; Dent - Small / (L) Rear Fender, Molding - Scratch &amp; Dent - Small / (L) Rear Door, Molding - Scratch &amp; Dent - Small / (L) Step, In-panel, Side Spoiler - Scratch &amp; Dent - Small / Rear Bumper, Lamps, Panels - Scratch &amp; Dent - Small / Trunk Hood, Rear Gate - Scratch &amp; Dent - Small / (R) Rear Door, Molding - Scratch - Large / (R) Step, In-panel, Side Spoiler - Scratch &amp; Dent - Small / (R) Front Door, Molding - Scratch - Small / (R) Front Fender, Molding - Scratch &amp; Dent - Small / Bonnet, Headlight - Scratch - Medium / Front Bumper, Grille, Lamps - Scratch - Medium / Roof - Scratch - Medium</p>

<p><b>Inspector Notes</b></p>
<p>with LTO plate, with manual &amp; warranty booklet, with spare key, with spare tire, with jack, with reverse camera, no tools, scratches on taillight &amp; headlight.</p>
