General Information

Make	Toyota	Model	Vios
YOM	2022	Odo Meter Reading	46,853
Registration No.	NGQ3570	Chassis No.	PA1B18F30N6008064
CC	1.5	Transmission	CVT
Fuel Type	Gas	Type of Body	Sedan
Colour	Green

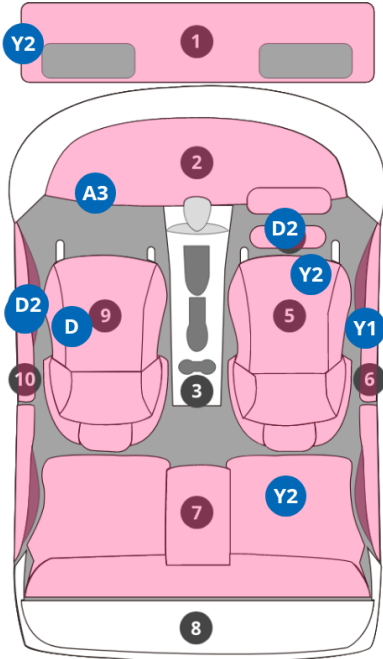
Interior Evaluation : C	Exterior Evaluation : C

<p>a : Cut, Fray d : Loose, Deformed k : Animal Hair s : Smell t : Cigarette Burns x : Defective y : Stain</p>

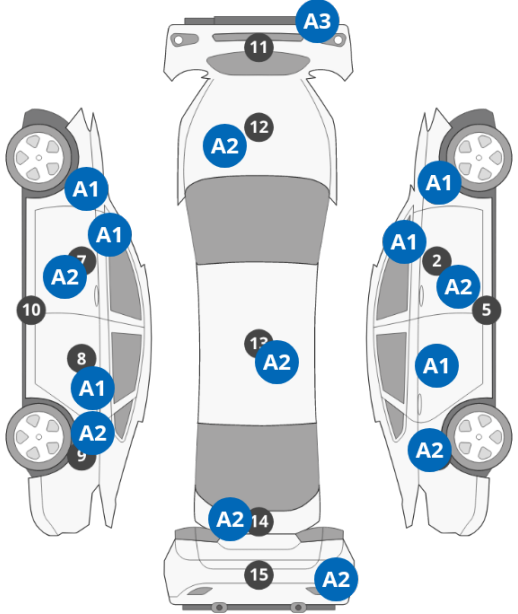
<p>A : Scratch AU : Scratch & Dent B : Modified C : Corrosion G : Stone chip P : Faded S : Rust SC : Rust & Corrosion U : Dent X : Defective Y : Crack, Gap</p>
<p>Remarks (L) Front Seat - Worn - Yes / (R) Front Seat - Grime - Small / (L) Front Floor Mat - Worked - Small / (L) Front Trim - Grime - Medium / (L) Front Trim - Worked - Small / (R) Front Trim - Grime - Minimal / Ceiling - Grime - Small / Rear Seat - Grime - Small / Steering Wheel - Worn, Peel, Crack - Medium</p>	<p>Remarks (R) Front Fender, Molding - Scratch - Minimal / (R) Mirror - Scratch - Minimal / (R) Front Door, Molding - Scratch - Small / (R) Rear Door, Molding - Scratch - Minimal / (R) Rear Fender, Molding - Scratch - Small / Rear Bumper, Lamps, Panels - Scratch - Small / Trunk Hood, Rear Gate - Scratch - Small / (L) Rear Fender, Molding - Scratch - Small / (L) Front Door, Molding - Scratch - Small / (L) Rear Door, Molding - Scratch - Minimal / (L) Mirror - Scratch - Minimal / (L) Front Fender, Molding - Scratch - Minimal / Front Bumper, Grille, Lamps - Scratch - Medium / Bonnet, Headlight - Scratch - Small / Roof - Scratch - Small</p>

<p>Inspector Notes</p>
<p>with warranty booklet, jack and tools, with spare tire, with LTO plate, scratches on tail light and headlight</p>
