General Information

Make	Toyota	Model	Vios
YOM	2025	Odo Meter Reading	11,175
Registration No.	DBS7415	Chassis No.	PA1B18F39R4277438
CC	1.3	Transmission	CVT
Fuel Type	Gas	Type of Body	Sedan
Colour	Silver

Body / Panel Condition

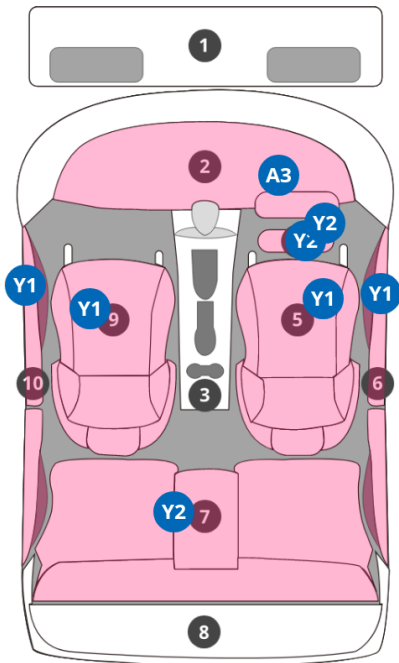
Interior Evaluation : B	Exterior Evaluation : D

<p>A : Scratch AU : Scratch & Dent B : Modified C : Corrosion G : Stone chip P : Faded S : Rust SC : Rust & Corrosion U : Dent X : Defective Y : Crack, Gap</p>
<p>Remarks Dashboard - Worn, Scratch, Cut, Crack - Medium / (L) Front Seat - Grime - Minimal / (R) Front Seat - Grime - Minimal / (R) Front Floor Mat - Grime - Small / (L) Front Floor Mat - Grime - Small / (L) Front Trim - Grime - Minimal / (R) Front Trim - Grime - Minimal / Rear Seat - Grime - Small</p>	<p>Remarks (L) Front Fender - Repair Traces - Yes / (L) Front Door - Repair Traces - Yes / (L) Step - Repair Traces - Yes / (L) Rear Fender, Molding - Scratch & Dent - Small / Trunk Hood, Rear Gate - Scratch & Dent - Small / Rear Bumper, Lamps, Panels - Scratch & Dent - Small / (L) Rear Door, Molding - Scratch & Dent - Small / (L) Front Door, Molding - Repair mark - Yes / (L) Front Fender, Molding - Repair mark - Yes / (L) Front Door, Molding - Scratch & Dent - Minimal / (L) Front Fender, Molding - Scratch - Small / Roof - Scratch - Small / Bonnet, Headlight - Repair mark - Yes / Bonnet, Headlight - Scratch - Small / (R) Front Fender, Molding - Scratch & Dent - Small / (R) Front Door, Molding - Scratch & Dent - Medium / (R) Rear Door, Molding - Scratch & Dent - Small / (R) Rear Fender, Molding - Scratch - Medium</p>
