General Information

Make	Toyota	Model	Vios
YOM	2022	Odo Meter Reading	51,386
Registration No.	NEN8463	Chassis No.	PA1B18F32N4183962
CC	1.3	Transmission	CVT
Fuel Type	Gas	Type of Body	Sedan
Colour	Green

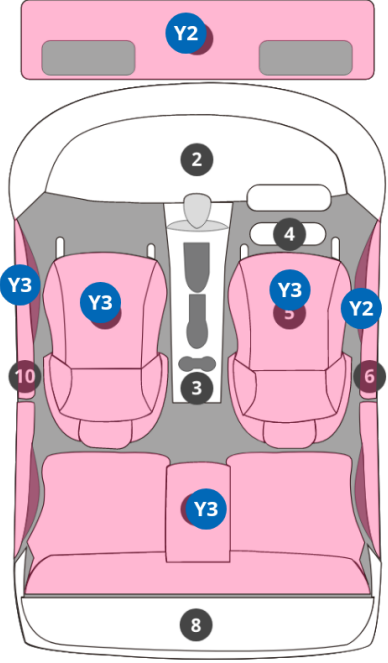
Interior Evaluation : C	Exterior Evaluation : E

<p>a : Cut, Fray d : Loose, Deformed k : Animal Hair s : Smell t : Cigarette Burns x : Defective y : Stain</p>

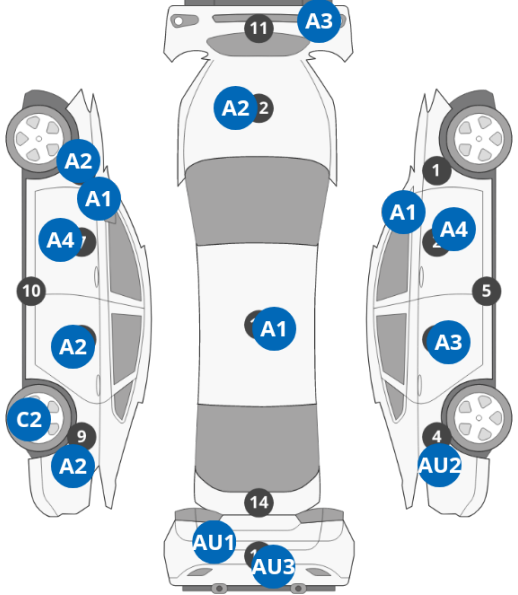
<p>A : Scratch AU : Scratch & Dent B : Modified C : Corrosion G : Stone chip P : Faded S : Rust SC : Rust & Corrosion U : Dent X : Defective Y : Crack, Gap</p>
<p>Remarks (R) Front Trim - Grime - Small / (R) Front Seat - Grime - Medium / Rear Seat - Grime - Medium / (L) Front Trim - Grime - Medium / (L) Front Seat - Grime - Medium / Ceiling - Grime - Small</p>	<p>Remarks Trunk Hood, Rear Gate - Scratch & Dent - Minimal / Rear Bumper, Lamps, Panels - Scratch & Dent - Medium / (L) Rear Fender, Molding - Scratch - Small / (L) Rear Door, Molding - Scratch - Small / (L) Front Door, Molding - Scratch - Large / (L) Front Fender, Molding - Scratch - Small / Front Bumper, Grille, Lamps - Scratch - Medium / Bonnet, Headlight - Scratch - Small / (L) Mirror - Scratch - Minimal / (R) Mirror - Scratch - Minimal / (R) Front Door, Molding - Scratch - Large / (R) Rear Door, Molding - Scratch - Medium / Roof - Scratch - Minimal / (R) Rear Fender, Molding - Scratch & Dent - Small / (L) Rear Wheel, Cover - Scratch, Corrosion - Small</p>
