## General Information

| Make | Toyota | Model | Hilux |
| Registration No. | NHS8439 | Chassis No. | MR0JB8DD4R3232320 |

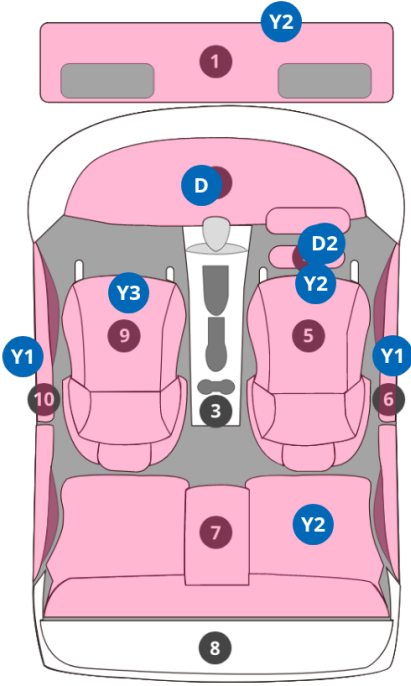
| Interior Evaluation : <span style="color: red; font-weight: bold;">B</span> | Exterior Evaluation : <span style="color: red; font-weight: bold;">E</span> |
| <p><b>Remarks</b><br/> (R) Front Trim - Grime - Minimal / (L) Front Trim - Grime - Minimal / (L) Front Seat - Grime - Medium / (R) Front Seat - Grime - Small / Rear Seat - Grime - Small / Ceiling - Grime - Small / (L) Front Floor Mat - Worked - Small / Mat Other - Worked - Small / Dashboard - Traces of Adhesive Tape - Yes</p> | <p><b>Remarks</b><br/> (R) Front Fender, Molding - Scratch - Small / (R) Mirror - Scratch - Minimal / (R) Front Door, Molding - Scratch - Minimal / (R) Rear Door, Molding - Scratch - Small / (R) Side Gate - Scratch - Small / (L) Side Gate - Scratch - Small / Rear Gate - Dent - Small / Rear Bumper, Lamps, Panels - Scratch - Medium / (R) Side Gate - Modified - Medium / (L) Side Gate - Modified - Medium / Cab Back Panel - Modified - Medium / Rear Gate - Modified - Small / (L) Rear Door, Molding - Scratch - Minimal / (L) Front Door, Molding - Scratch - Minimal / (L) Mirror - Scratch - Minimal / (L) Front Fender, Molding - Scratch - Minimal / Front Bumper, Grille, Lamps - Scratch - Medium / Bonnet, Headlight - Scratch - Minimal / Roof - Scratch - Small</p> |

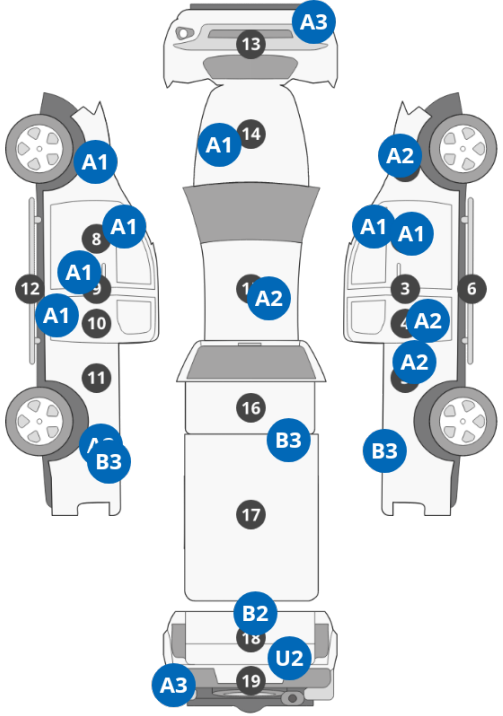
| Inspector Notes |
|---|
| <p>no warranty booklet, with jack and tools, with spare tire, with LTO plate, scratches on tail light,</p> |
