## General Information

| <b>Make</b> | Toyota | <b>Model</b> | Vios |

## Body / Panel Condition

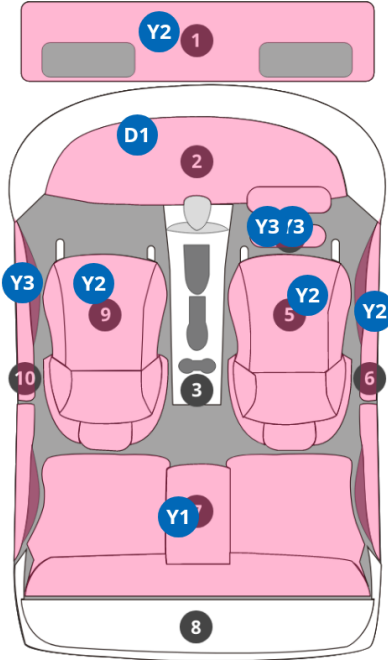
| <b>Interior Evaluation :</b> <span style="float: right; color: red; font-weight: bold;">C</span> | <b>Exterior Evaluation :</b> <span style="float: right; color: red; font-weight: bold;">E</span> |
| <p><b>Remarks</b><br/>Dashboard - Worked - Minimal / Ceiling - Grime - Small / (L) Front Trim - Grime - Medium / (L) Front Seat - Grime - Small / (R) Front Floor Mat - Grime - Medium / (L) Front Floor Mat - Grime - Medium / (R) Front Trim - Grime - Small / Rear Seat - Grime - Minimal / (R) Front Seat - Grime - Small</p> | <p><b>Remarks</b><br/>Roof - Scratch &amp; Dent - Small / (L) Step, In-panel, Side Spoiler - Scratch &amp; Dent - Small / (R) Step, In-panel, Side Spoiler - Scratch &amp; Dent - Small / Bonnet, Headlight - Scratch &amp; Dent - Large / Front Bumper, Grille, Lamps - Scratch &amp; Dent - Large / Front Bumper, Grille, Lamps - Modified - Medium / (R) Front Fender, Molding - Scratch &amp; Dent - Medium / (R) Front Door, Molding - Scratch &amp; Dent - Large / Rear Bumper, Lamps, Panels - Scratch &amp; Dent - Medium / Trunk Hood, Rear Gate - Scratch &amp; Dent - Small / (L) Rear Fender, Molding - Scratch - Small / (L) Rear Door, Molding - Scratch &amp; Dent - Small / (L) Front Door, Molding - Scratch - Medium / (L) Front Fender, Molding - Scratch &amp; Dent - Small / (R) Rear Door, Molding - Scratch &amp; Dent - Large / (R) Rear Fender, Molding - Scratch &amp; Dent - Medium</p> |
