## General Information

| Make | Toyota | Model | Vios |
| Registration No. | DBM6648 | Chassis No. | PA1B18F32R4247584 |

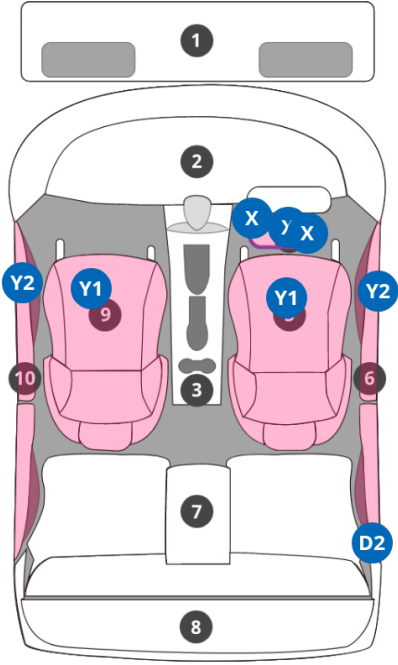
| Interior Evaluation : <b>B</b> | Exterior Evaluation : <b>E</b> |
| <p><b>Remarks</b></p> <p>(R) Front Floor Mat - Missing - Yes / (L) Front Floor Mat - Missing - Yes / Mat Other - Missing - Yes / (R) Front Trim - Grime - Small / (L) Front Trim - Grime - Small / (L) Front Seat - Grime - Minimal / (R) Front Seat - Grime - Minimal / Trim Other - Loose, Deformed - Small</p> | <p><b>Remarks</b></p> <p>Roof - Scratch &amp; Dent - Small / (L) Rear Fender, Molding - Scratch - Medium / (R) Rear Fender, Molding - Scratch - Small / (R) Rear Door, Molding - Scratch &amp; Dent - Medium / (R) Step, In-panel, Side Spoiler - Scratch &amp; Dent - Small / (L) Step, In-panel, Side Spoiler - Scratch - Medium / (L) Front Door, Molding - Scratch - Medium / (L) Rear Door, Molding - Scratch - Medium / (R) Front Door, Molding - Scratch - Medium / Bonnet, Headlight - Scratch - Medium / Front Bumper, Grille, Lamps - Scratch &amp; Dent - Medium / (L) Front Fender, Molding - Scratch &amp; Dent - Small / Trunk Hood, Rear Gate - Scratch - Medium / Rear Bumper, Lamps, Panels - Scratch &amp; Dent - Small / (R) Front Fender, Molding - Scratch - Small</p> |

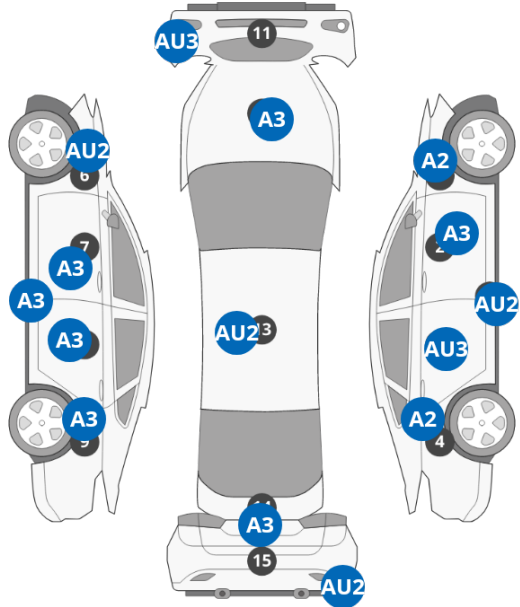
| Inspector Notes |
|---|
| <p>with LTO plate, with manual &amp; warranty booklet, with reverse camera, with inc tools &amp; jack, no spare key, no spare tire, scratches on taillight.</p> |
