## General Information

| Make | Toyota | Model | Hiace |
| YOM | 2024 | Odo Meter Reading | 32,034 |

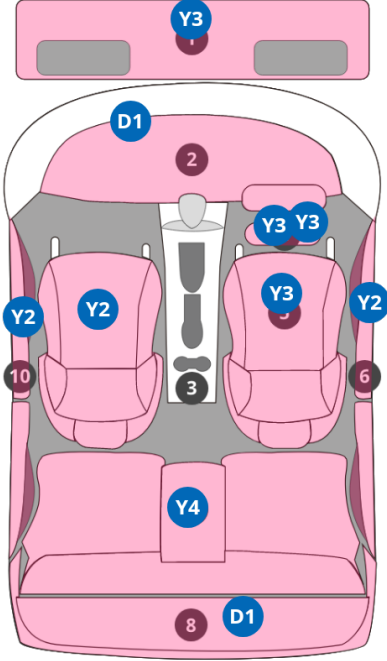
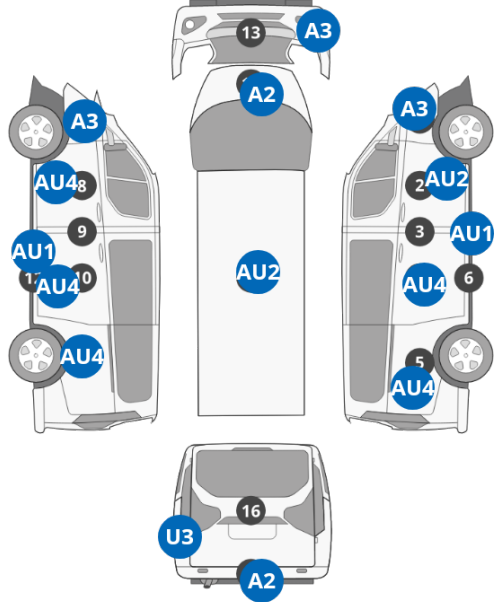
| Interior Evaluation : <b>C</b> | Exterior Evaluation : <b>E</b> |
| <p><b>a</b> : Cut, Fray <b>d</b> : Loose, Deformed <b>k</b> : Animal Hair <b>s</b> : Smell <b>t</b> : Cigarette Burns <b>x</b> : Defective <b>y</b> : Stain</p> | <p><b>A</b> : Scratch <b>AU</b> : Scratch &amp; Dent <b>B</b> : Modified <b>C</b> : Corrosion <b>G</b> : Stone chip <b>P</b> : Faded <b>S</b> : Rust <b>SC</b> : Rust &amp; Corrosion <b>U</b> : Dent <b>X</b> : Defective <b>Y</b> : Crack, Gap</p> |
| <p><b>Remarks</b></p> <p>Dashboard - Worked - Minimal / Ceiling - Grime - Medium / (R) Front Seat - Grime - Medium / (L) Front Seat - Grime - Small / (L) Front Trim - Grime - Small / (R) Front Trim - Grime - Small / Rear Seat - Grime - Large / Trunk Room - Worked - Minimal / (R) Front Floor Mat - Grime - Medium / (L) Front Floor Mat - Grime - Medium</p> | <p><b>Remarks</b></p> <p>(R) Rear Door - Repair Traces - Yes / (R) Center Panel - Repair Traces - Yes / (L) Rear Fender, Molding - Scratch &amp; Dent - Large / Rear Bumper, Lamps, Panels - Scratch - Small / Trunk Hood, Rear Gate - Dent - Medium / (R) Rear Fender, Molding - Scratch &amp; Dent - Large / (R) Rear Door, Molding - Scratch &amp; Dent - Large / (R) Front Door, Molding - Scratch &amp; Dent - Small / (R) Step, In-panel, Side Spoiler - Scratch &amp; Dent - Minimal / (L) Step, In-panel, Side Spoiler - Scratch &amp; Dent - Minimal / (L) Rear Door, Molding - Scratch &amp; Dent - Large / (L) Front Door, Molding - Scratch &amp; Dent - Large / Roof - Scratch &amp; Dent - Small / Bonnet, Headlight - Scratch - Small / Front Bumper, Grille, Lamps - Scratch - Medium / (R) Front Fender, Molding - Scratch - Medium / (L) Front Fender, Molding - Scratch - Medium</p> |
