## General Information

| Make | Toyota | Model | Vios |
| Registration No. | NHU4386 | Chassis No. | PA1B18F31R4270435 |

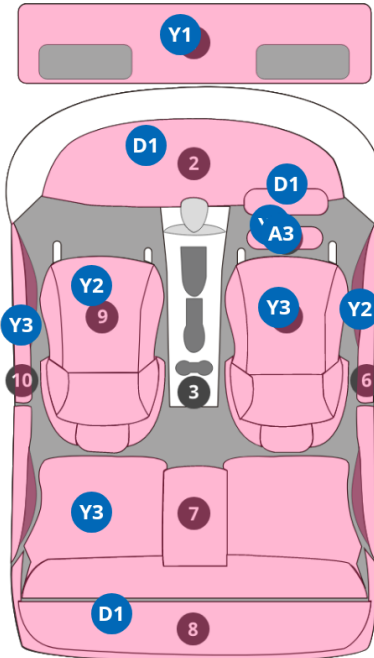
| <div> <div>Interior Evaluation :</div> <div>C</div> </div> | <div> <div>Exterior Evaluation :</div> <div>E</div> </div> |
| <div> <div>Remarks</div> <div>Dashboard - Worked - Minimal / Glove Box - Worked - Minimal / (L) Front Trim - Grime - Medium / (L) Front Seat - Grime - Small / (R) Front Seat - Grime - Medium / Rear Seat - Grime - Medium / Trunk Room - Worked - Minimal / (R) Front Trim - Grime - Small / (R) Front Floor Mat - Grime - Medium / (L) Front Floor Mat - Cut, Crack - Medium / Ceiling - Grime - Minimal</div> </div> | <div> <div>Remarks</div> <div>(L) Rear Door - Repair Traces - Yes / Roof - Repair Traces - Yes / Front Bumper, Grille, Lamps - Scratch - Medium / Bonnet, Headlight - Scratch &amp; Dent - Small / (L) Front Fender, Molding - Crack, Gap - Small / (R) Front Fender, Molding - Scratch &amp; Dent - Small / (R) Front Door, Molding - Scratch &amp; Dent - Medium / (R) Step, In-panel, Side Spoiler - Scratch &amp; Dent - Large / (R) Rear Door, Molding - Scratch &amp; Dent - Small / (R) Rear Fender, Molding - Scratch &amp; Dent - Large / Rear Bumper, Lamps, Panels - Scratch - Medium / Trunk Hood, Rear Gate - Scratch - Small / (L) Rear Fender, Molding - Scratch - Medium / (L) Step, In-panel, Side Spoiler - Scratch &amp; Dent - Small / (L) Rear Door, Molding - Scratch &amp; Dent - Small / (L) Front Door, Molding - Scratch &amp; Dent - Small / Roof - Scratch &amp; Dent - Small</div> </div> |
