## General Information

<b>Make</b>	Nissan	<b>Model</b>	NV350
<b>YOM</b>	2020	<b>Odo Meter Reading</b>	102,640
<b>Registration No.</b>	GAO1469	<b>Chassis No.</b>	JN1TC2E26Z0060526
<b>CC</b>	2.5	<b>Transmission</b>	M/T
<b>Fuel Type</b>	Diesel	<b>Type of Body</b>	Van
<b>Colour</b>	White

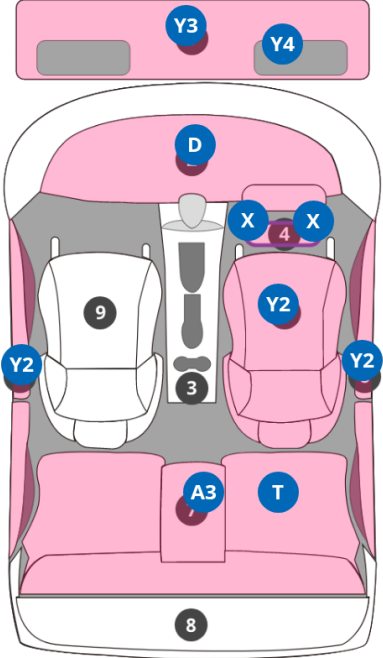
<b>Interior Evaluation :</b> <span style="float: right; color: red; font-weight: bold;">C</span>	<b>Exterior Evaluation :</b> <span style="float: right; color: red; font-weight: bold;">E</span>

<p><b>a</b> : Cut, Fray <b>d</b> : Loose, Deformed <b>k</b> : Animal Hair <b>s</b> : Smell <b>t</b> : Cigarette Burns <b>x</b> : Defective <b>y</b> : Stain</p>

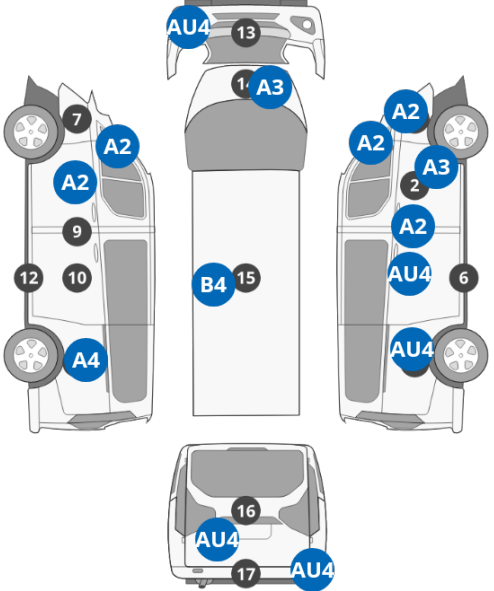
<p><b>A</b> : Scratch <b>AU</b> : Scratch &amp; Dent <b>B</b> : Modified <b>C</b> : Corrosion <b>G</b> : Stone chip <b>P</b> : Faded <b>S</b> : Rust <b>SC</b> : Rust &amp; Corrosion <b>U</b> : Dent <b>X</b> : Defective <b>Y</b> : Crack, Gap</p>
<p><b>Remarks</b> Sunvisor, Sunglass Holder - Grime - Large / Ceiling - Grime - Medium / (L) Front Floor Mat - Missing - Yes / (R) Front Floor Mat - Missing - Yes / Rear Seat - Cut, Crack - Medium / Rear Seat - Cigarette Burns - Burnt / Dashboard - Traces of Adhesive Tape - Yes / (L) Front Trim - Grime - Small / (R) Front Trim - Grime - Small / (R) Front Seat - Grime - Small</p>	<p><b>Remarks</b> (R) Front Door - Repair Traces - Yes / (R) Front Fender - Repair Traces - Yes / Bonnet - Repair Traces - Yes / (L) Front Fender - Repair Traces - Yes / (L) Front Door - Repair Traces - Yes / (L) Rear Fender - Repair Traces - Yes / (R) Rear Fender - Repair Traces - Yes / (R) Rear Door - Repair Traces - Yes / (R) Center Panel - Repair Traces - Yes / Roof - Repair Traces - Yes / (L) Mirror - Scratch - Small / (R) Front Fender, Molding - Scratch - Small / (R) Mirror - Scratch - Small / Front Bumper, Grille, Lamps - Scratch &amp; Dent - Large / (L) Front Door, Molding - Scratch - Small / (R) Front Door, Molding - Scratch - Medium / (R) Center Panel - Scratch - Small / (R) Rear Door, Molding - Scratch &amp; Dent - Large / (R) Rear Fender, Molding - Scratch &amp; Dent - Large / Trunk Hood, Rear Gate - Scratch &amp; Dent - Large / Rear Bumper, Lamps, Panels - Scratch &amp; Dent - Large / (L) Rear Fender, Molding - Scratch - Large / Roof - Modified - Large / Bonnet, Headlight - Scratch - Medium</p>
