## General Information

<b>Make</b>	Toyota	<b>Model</b>	Vios
<b>YOM</b>	2022	<b>Odo Meter Reading</b>	65,749
<b>Registration No.</b>	FAJ4456	<b>Chassis No.</b>	PA1B18F38N4177129
<b>CC</b>	1.3	<b>Transmission</b>	CVT
<b>Fuel Type</b>	Gas	<b>Type of Body</b>	Sedan
<b>Colour</b>	Red

## Body / Panel Condition

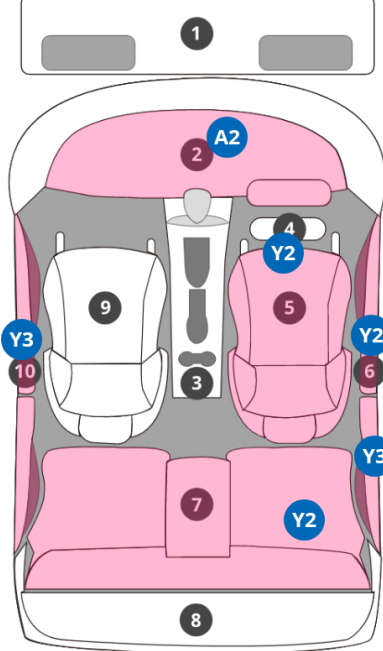
<b>Interior Evaluation :</b> <span style="float: right;"><b>B</b></span>	<b>Exterior Evaluation :</b> <span style="float: right;"><b>C</b></span>

<p><b>a</b> : Cut, Fray <b>d</b> : Loose, Deformed <b>k</b> : Animal Hair <b>s</b> : Smell <b>t</b> : Cigarette Burns <b>x</b> : Defective <b>y</b> : Stain</p>

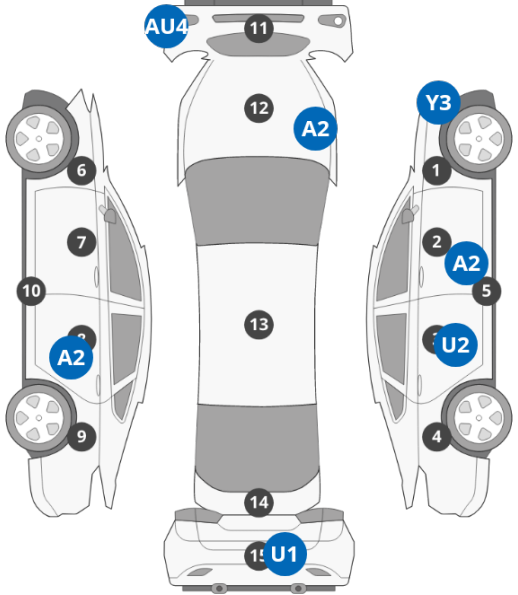
<p><b>A</b> : Scratch <b>AU</b> : Scratch &amp; Dent <b>B</b> : Modified <b>C</b> : Corrosion <b>G</b> : Stone chip <b>P</b> : Faded <b>S</b> : Rust <b>SC</b> : Rust &amp; Corrosion <b>U</b> : Dent <b>X</b> : Defective <b>Y</b> : Crack, Gap</p>
<p><b>Remarks</b> (R) Front Seat - Grime - Small / (R) Front Trim - Grime - Small / Rear Seat - Grime - Small / (R) Rear Trim - Grime - Medium / (L) Front Trim - Grime - Medium / Dashboard - Worn, Scratch, Cut, Crack - Small</p>	<p><b>Remarks</b> Bonnet - Repair Traces - Yes / (L) Front Fender - Repair Traces - Yes / (L) Front Door - Repair Traces - Yes / (R) Rear Door - Repair Traces - Yes / Front Bumper, Grille, Lamps - Scratch &amp; Dent - Large / (R) Front Fender, Molding - Crack, Gap - Medium / (R) Front Door, Molding - Scratch - Small / (R) Rear Door, Molding - Dent - Small / Trunk Hood, Rear Gate - Dent - Minimal / (L) Front Door, Molding - Scratch - Small / Bonnet, Headlight - Scratch - Small</p>
