General Information

Make	Toyota	Model	Vios
YOM	2023	Odo Meter Reading	5,401
Registration No.	DAS8722	Chassis No.	PA1B18F32N4194024
CC	1.3	Transmission	CVT
Fuel Type	Gas	Type of Body	Sedan
Colour	Silver

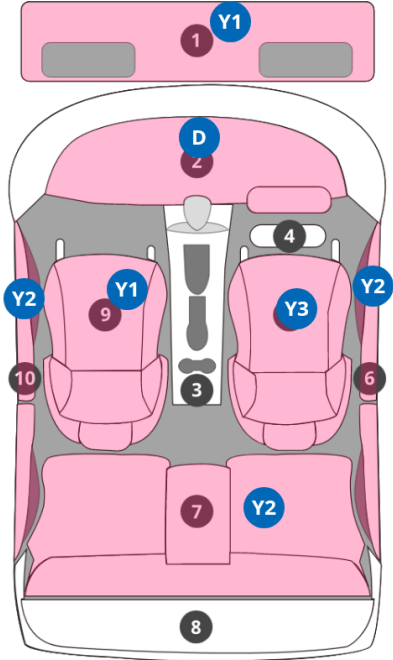
<p>a : Cut, Fray d : Loose, Deformed k : Animal Hair s : Smell t : Cigarette Burns x : Defective y : Stain</p>

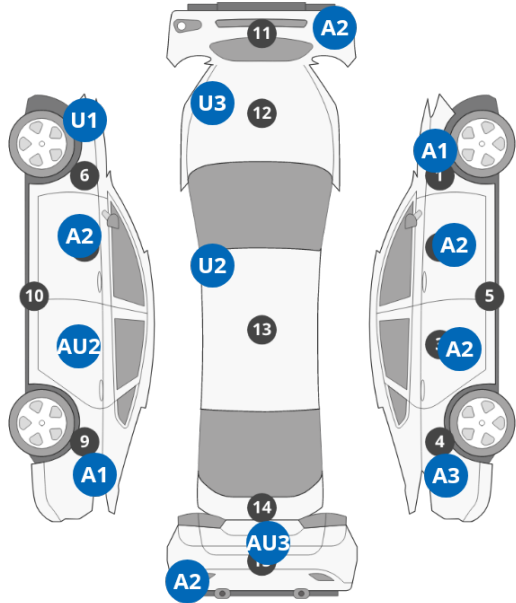
<p>A : Scratch AU : Scratch & Dent B : Modified C : Corrosion G : Stone chip P : Faded S : Rust SC : Rust & Corrosion U : Dent X : Defective Y : Crack, Gap</p>
<p>Remarks (R) Front Seat - Grime - Medium / (R) Front Trim - Grime - Small / Rear Seat - Grime - Small / (L) Front Trim - Grime - Small / (L) Front Seat - Grime - Minimal / Dashboard - Traces of Adhesive Tape - Yes / Ceiling - Grime - Minimal</p>	<p>Remarks Roof - Dent - Small / Bonnet, Headlight - Dent - Medium / Front Bumper, Grille, Lamps - Scratch - Small / (R) Front Fender, Molding - Scratch - Minimal / (R) Front Door, Molding - Scratch - Small / (R) Rear Door, Molding - Scratch - Small / (R) Rear Fender, Molding - Scratch - Medium / Rear Bumper, Lamps, Panels - Scratch - Small / Trunk Hood, Rear Gate - Scratch & Dent - Medium / (L) Rear Fender, Molding - Scratch - Minimal / (L) Rear Door, Molding - Scratch & Dent - Small / (L) Front Door, Molding - Scratch - Small / (L) Front Fender, Molding - Dent - Minimal</p>
